# 1965 BUICK DEALER SERVICE INFORMATION LETTER INDEX

Through November 30, 1965

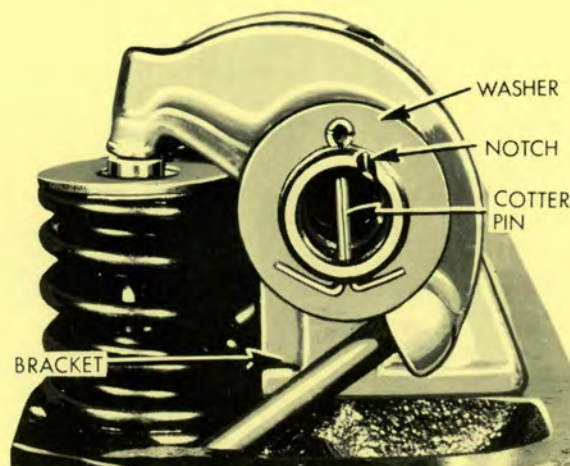
This illustration shows a correctly installed shaft. The notch on the end of the shaft must be in the position shown to properly position the lubricating holes at the bottom of the rocker arm.

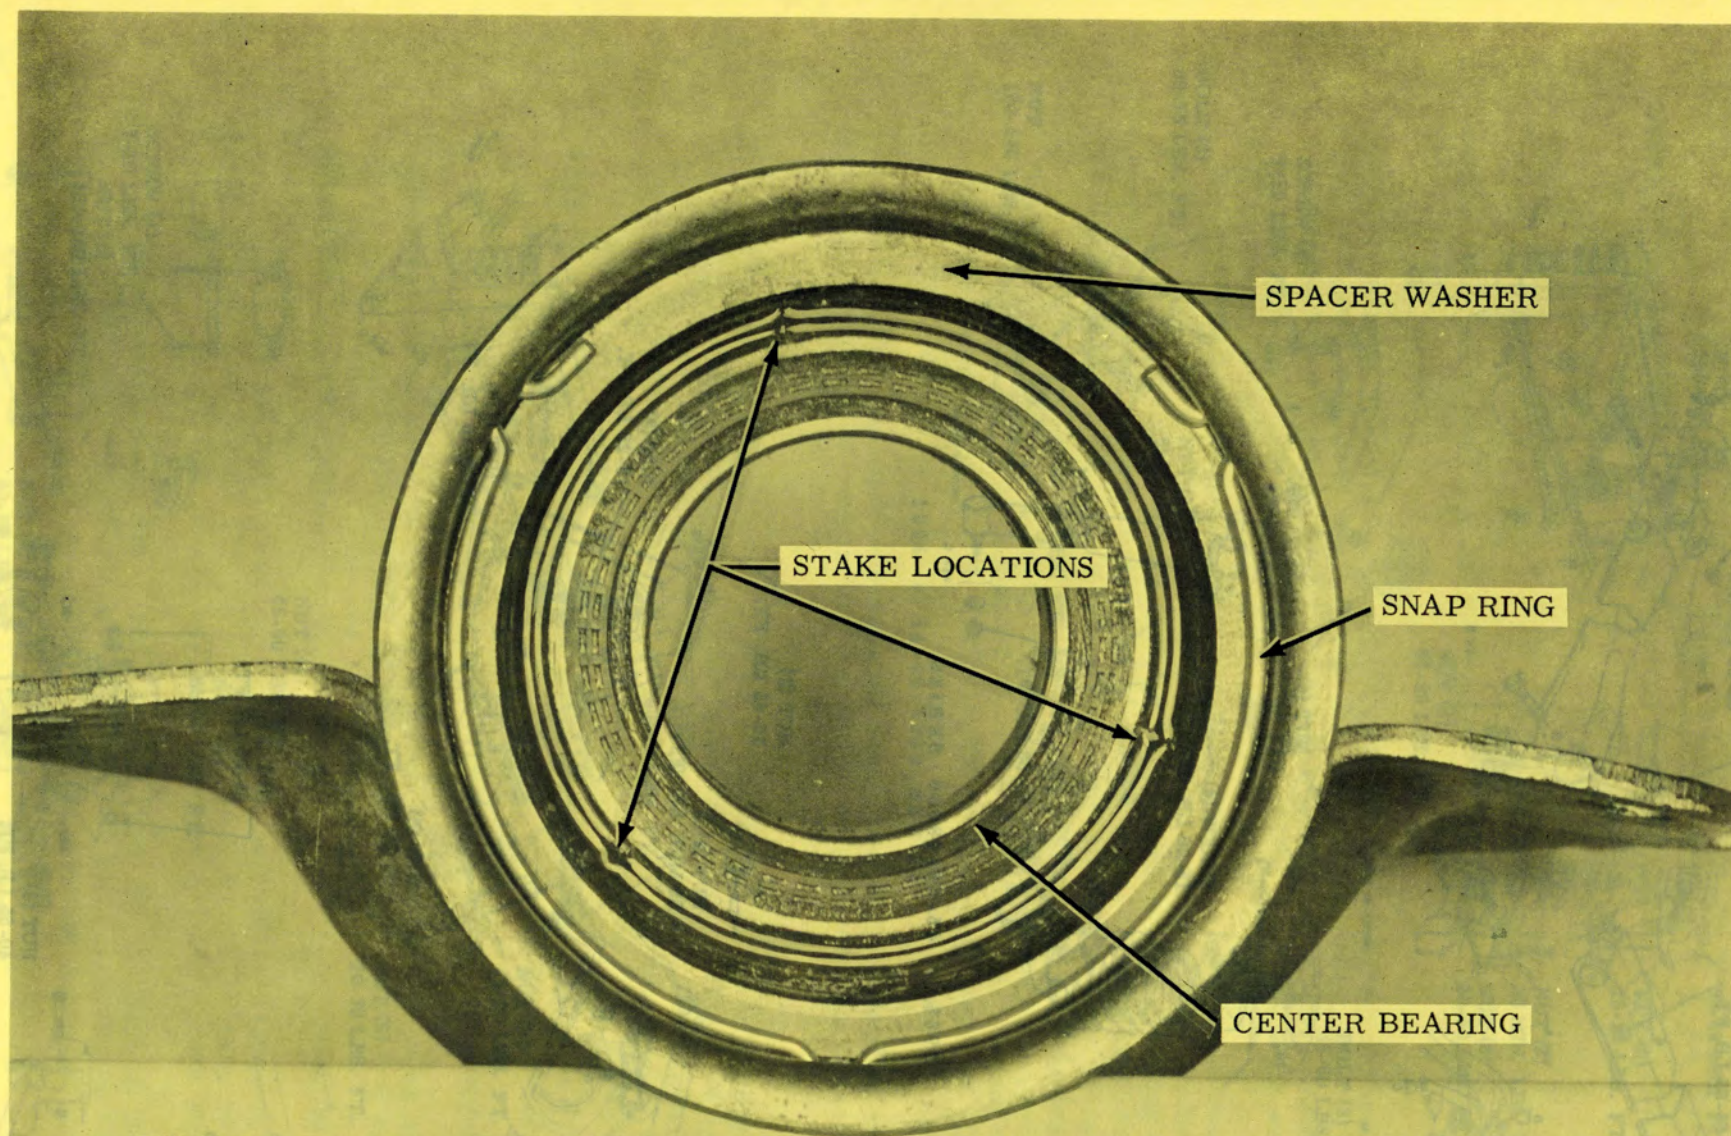
If labeled parts are missing or incorrectly installed it can cause a "clunking" noise in drive-line

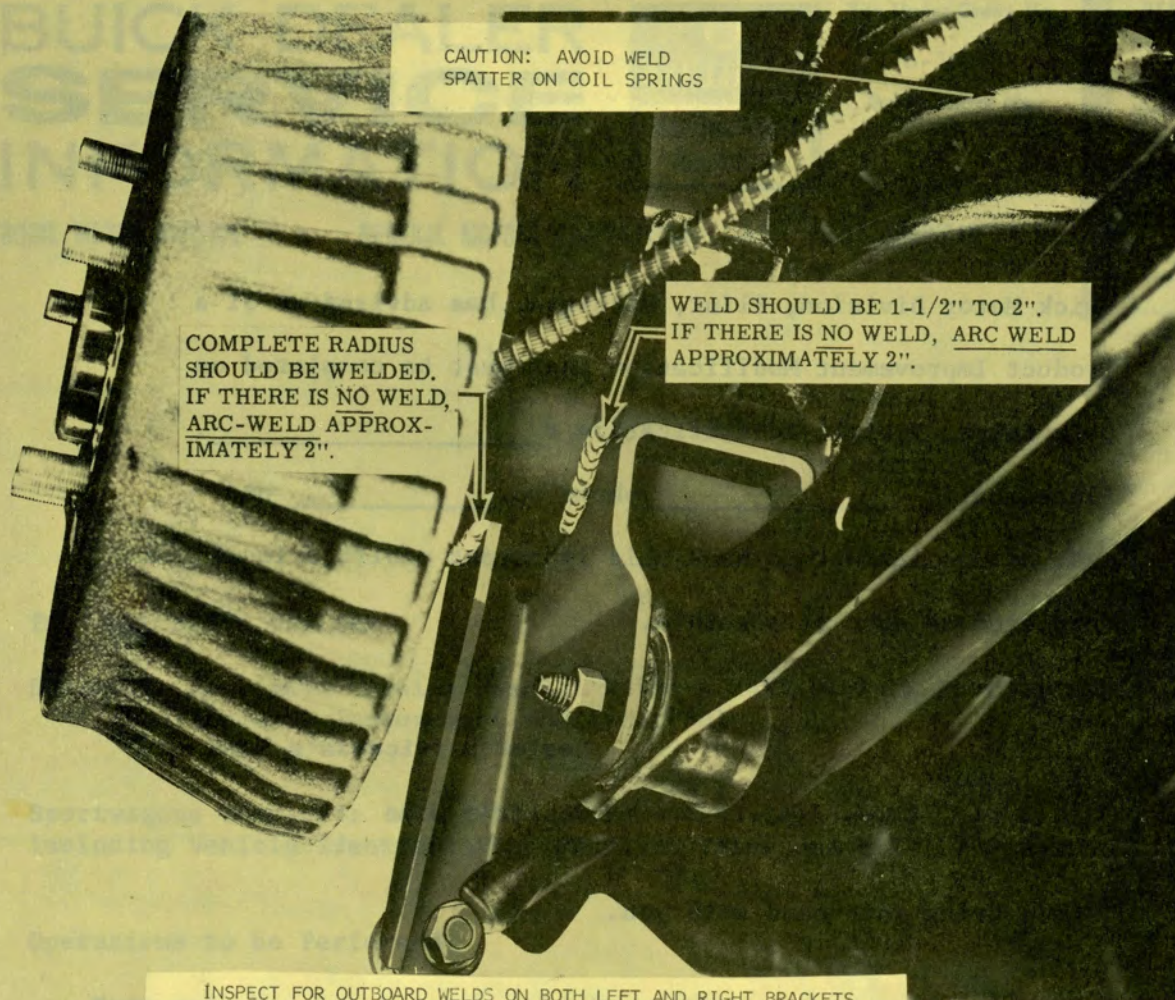
INSPECT FOR OUTBOARD WELDS ON BOTH LEFT AND RIGHT BRACKETS

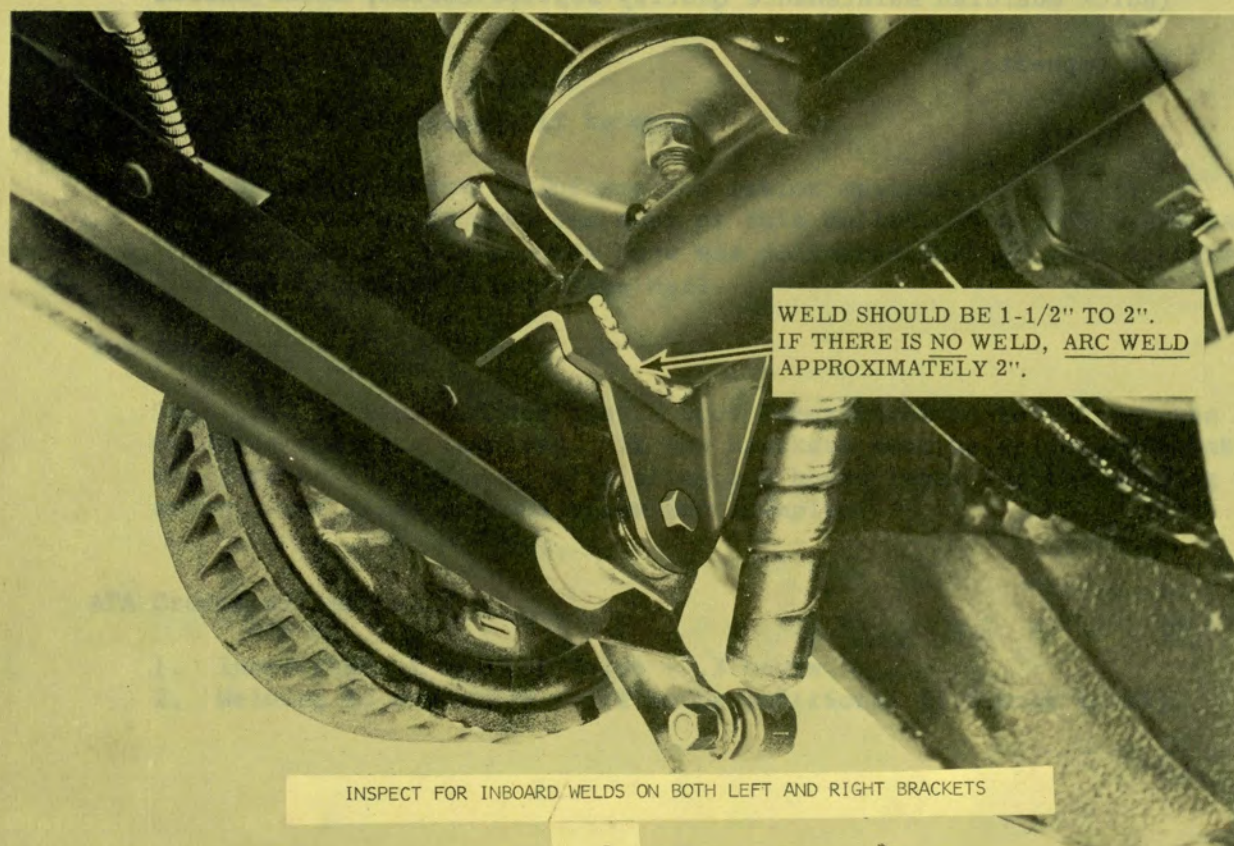
INSPECT FOR INBOARD WELDS ON BOTH LEFT AND RIGHT BRACKETS

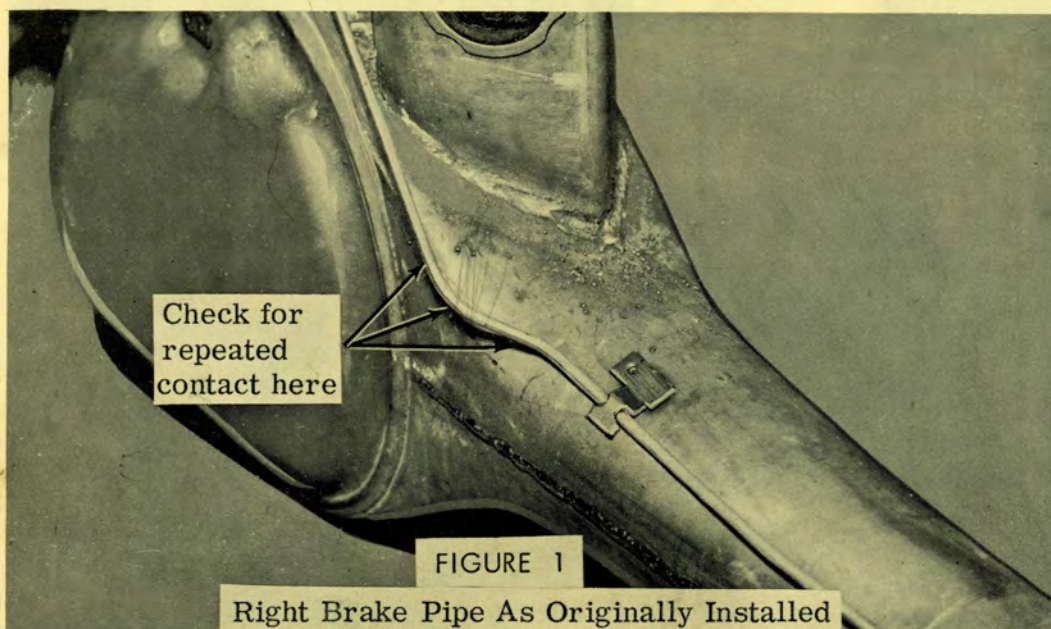
If there are signs of repeated contact, the brake pipe must be replaced with the late type which has a different shape.

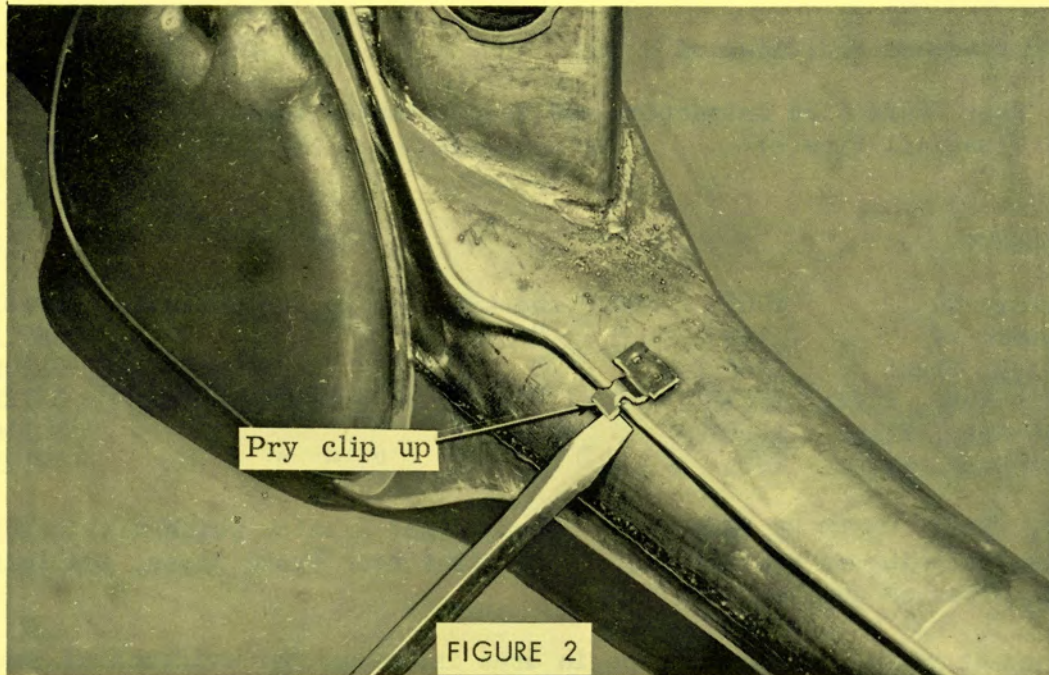
- B. If no contact is evident, or if only an occasional contact is evident the brake pipe need not be replaced; however, it still must be repositioned.

1. Pry up clip to disengage pipe. See Figure 2.  
Bend pipe or pipes forward against axle housing and re-engage in clip. See Figures 3 and 4.  
Bend clip down to original position to firmly hold pipe against axle housing.

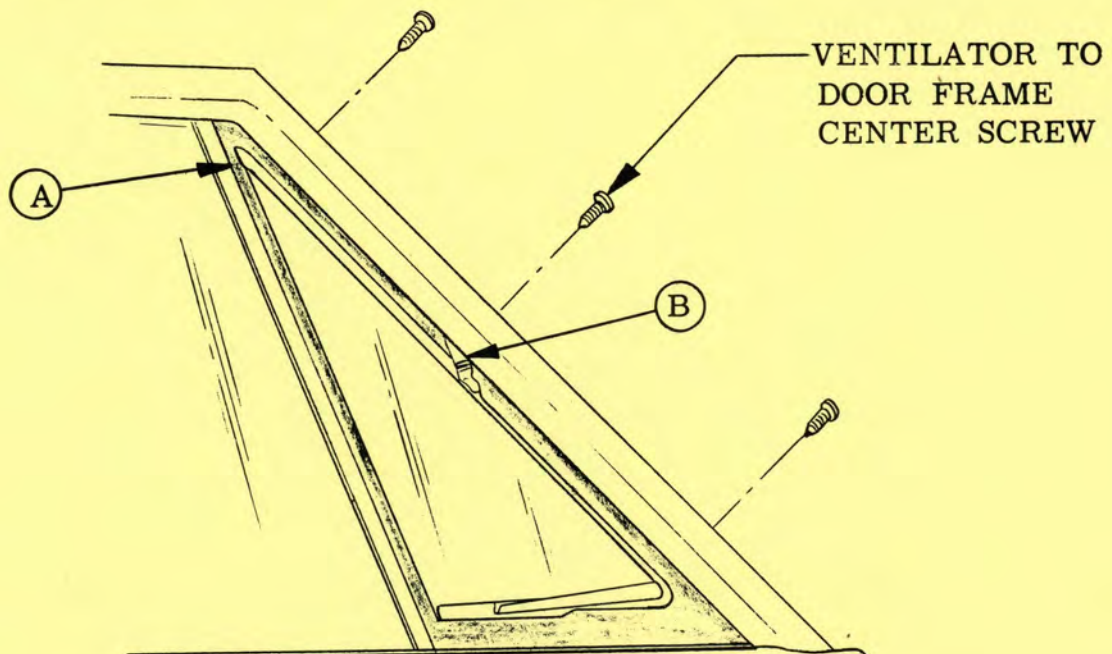
If there appears to be excessive movement, the screw is probably not completely tightened even though it may appear to be. To tighten the screw will require considerable torque because screw is self-drilling type and is being inserted into a stainless steel pad on the vent frame.

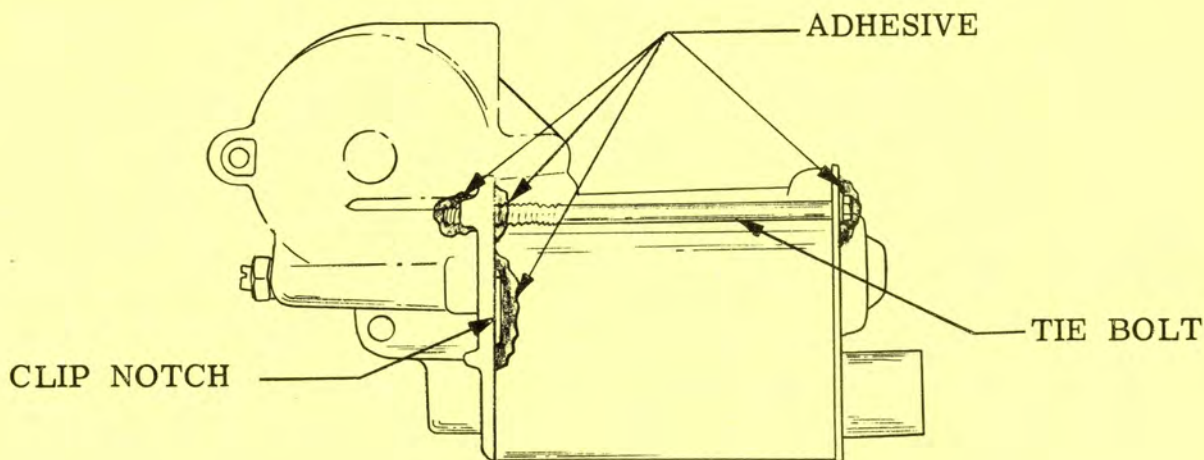
A primary cause of power window motor failures has been due to the entry of water. As a precautionary measure to prevent water entry, the application of black weatherstrip adhesive at the "tie bolts" (upper and lower ends) and at brush holder clip notch (See Illustration) is recommended on all service replacement motors with two (2) "tie bolts". Improved motors with three (3) "tie bolts" will not require added sealing.
