# 1965 BUICK DEALER SERVICE INFORMATION LETTER INDEX

Through November 30, 1965

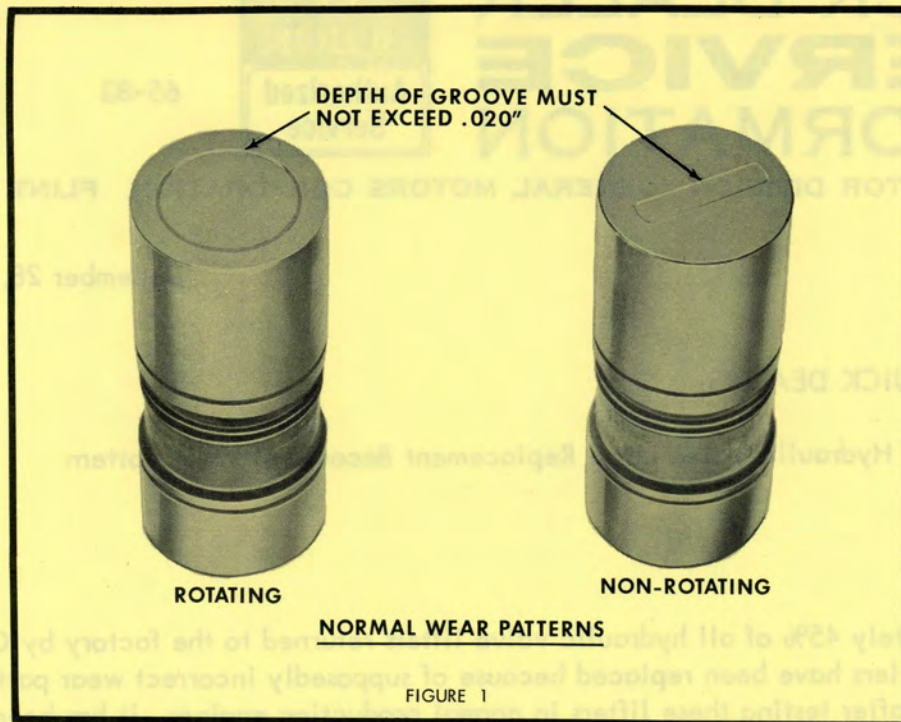
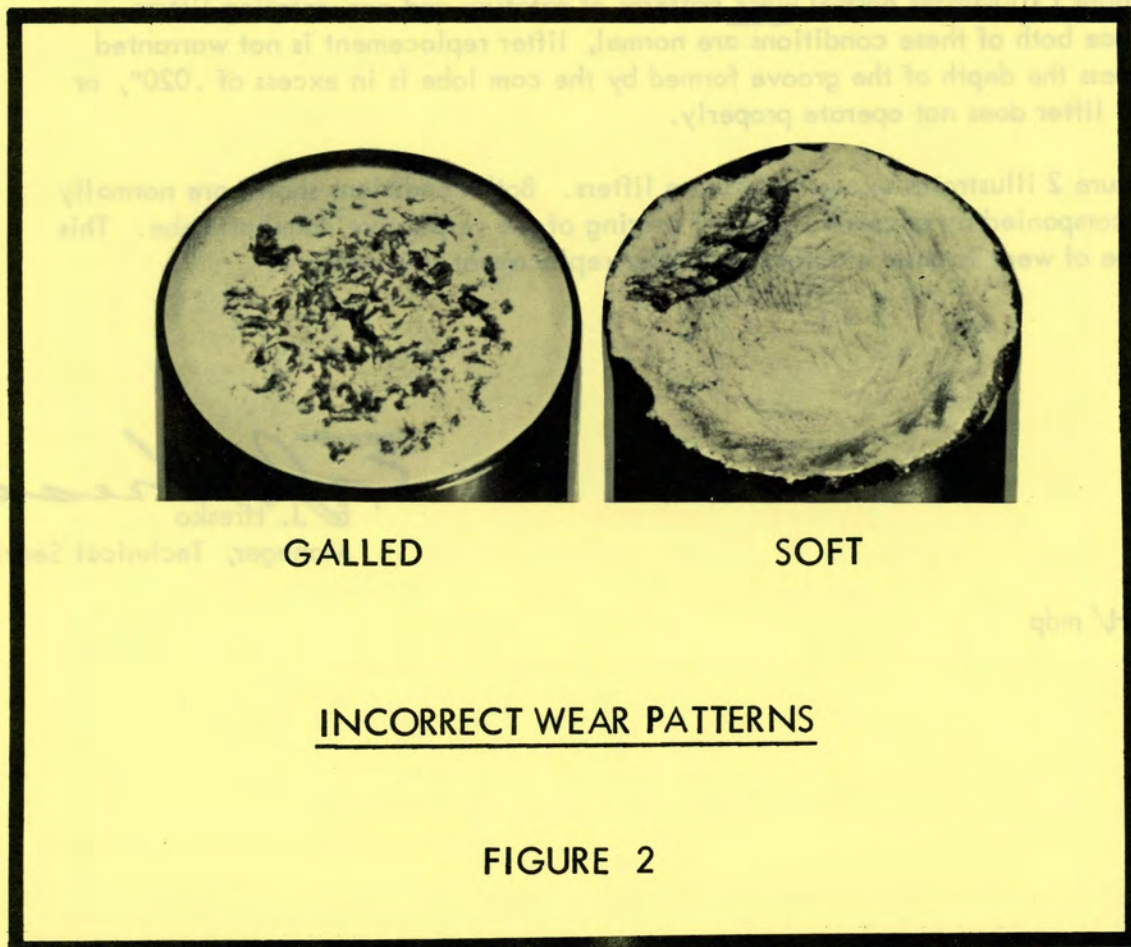
SUBJECT: Hydraulic Valve Lifter Replacement Because of Wear Pattern

Approximately 45% of all hydraulic valve lifters returned to the factory by Clear Signal Dealers have been replaced because of supposedly incorrect wear patterns. However, after testing these lifters in normal production engines, it has been found that 30% of these lifters are satisfactory. Therefore, it is important that Dealers learn to distinguish between normal and abnormal wear patterns.

Figure 1 illustrates normal wear patterns of rotating and non-rotating lifters. Since both of these conditions are normal, lifter replacement is not warranted unless the depth of the groove formed by the cam lobe is in excess of .020", or the lifter does not operate properly.

Figure 2 illustrates excessively worn lifters. Both conditions shown are normally accompanied by excessive wear or scoring of the respective camshaft lobe. This type of wear is unsatisfactory and lifter replacement is necessary.

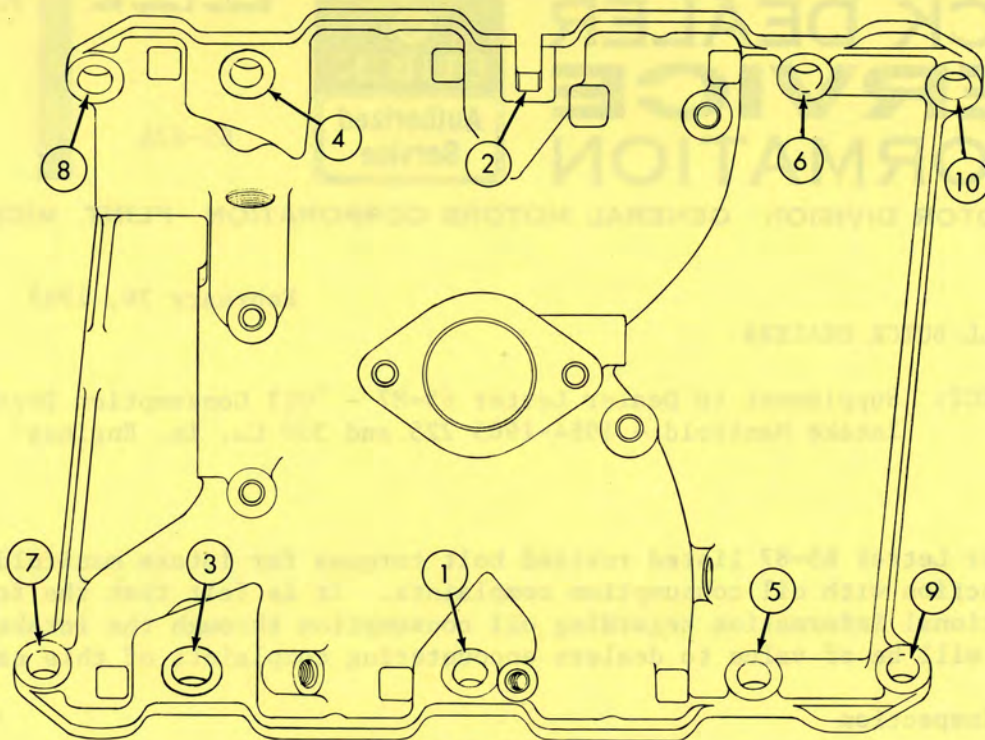
FIGURE 1

It has been found that insufficient torque on intake manifold bolts permits engine oil circulating in the vicinity of the lifter galleries to be drawn into the intake manifold. Therefore, it is important that the torque on these bolts be checked whenever oil consumption complaints are received.

V-6 INTAKE MANIFOLD  
BOLT TIGHTENING SEQUENCE

If a car has accumulated at least 4,000 miles and oil consumption is still a complaint, one of the more important items to check is the amount of torque on the intake manifold attaching bolts. In some cases, the bolts may be found to be loose, not allowing the manifold gaskets to seal properly. However, other cars may have correctly torqued manifold bolts and still draw oil from the crankcase into the cylinder head ports. Therefore, in order to check for this condition, the intake manifold should be removed so that the cylinder head ports can be checked for the presence of oil.

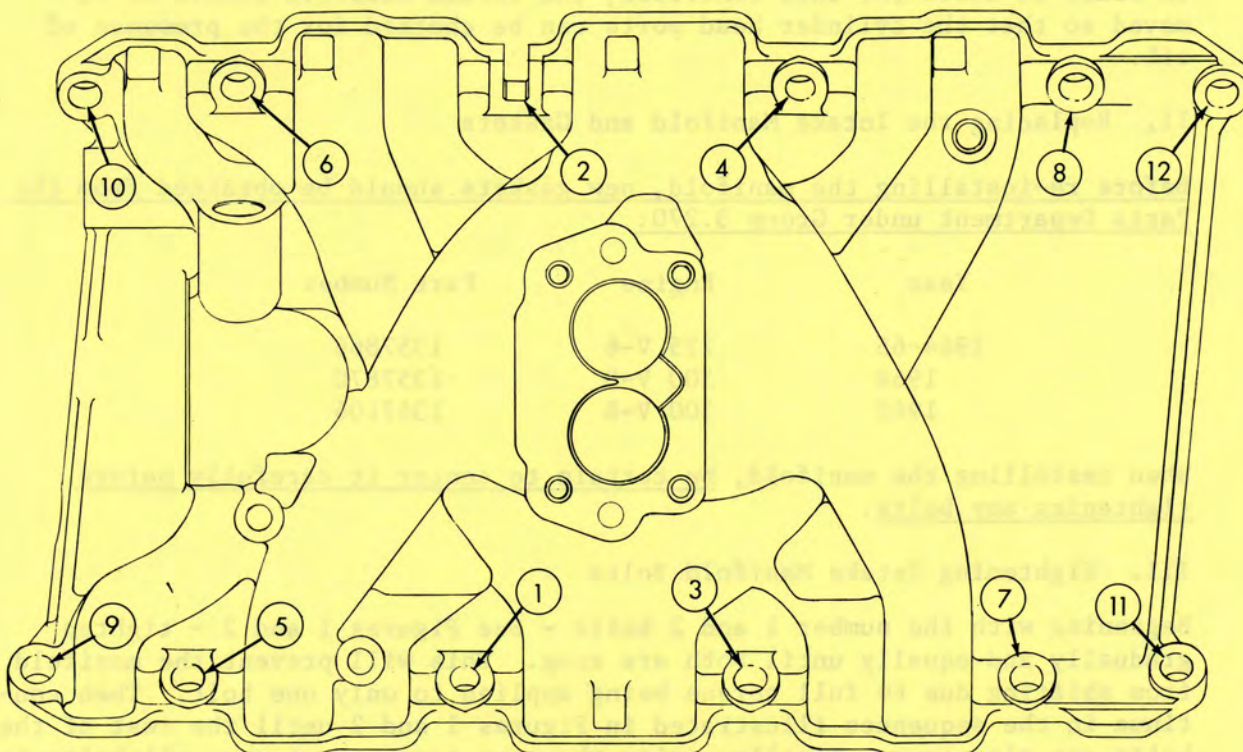
FIGURE 2

2 & 4 BARREL V-8 INTAKE MANIFOLD  
(300 ENGINE) BOLT TIGHTENING SEQUENCE

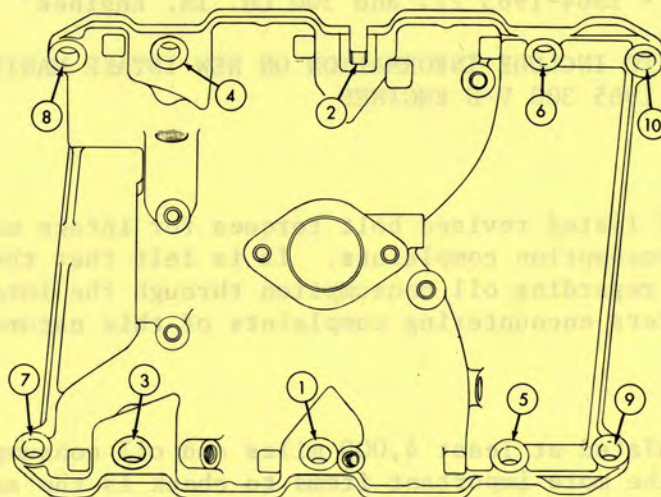
FIGURE 1

V-6 INTAKE MANIFOLD  
BOLT TIGHTENING SEQUENCE

Beginning with the number 1 and 2 bolts - See Figures 1 and 2 - tighten gradually and equally until both are snug. This will prevent the manifold from shifting due to full torque being applied to only one bolt. Then continue in the sequences illustrated in Figures 1 and 2 until the rest of the bolts are also snug. Finally, using the same sequence, torque all bolts to the specified ratings - 35-45 lb. ft. on 1964 engines and 45-55 lb. ft. on 1965 engines.

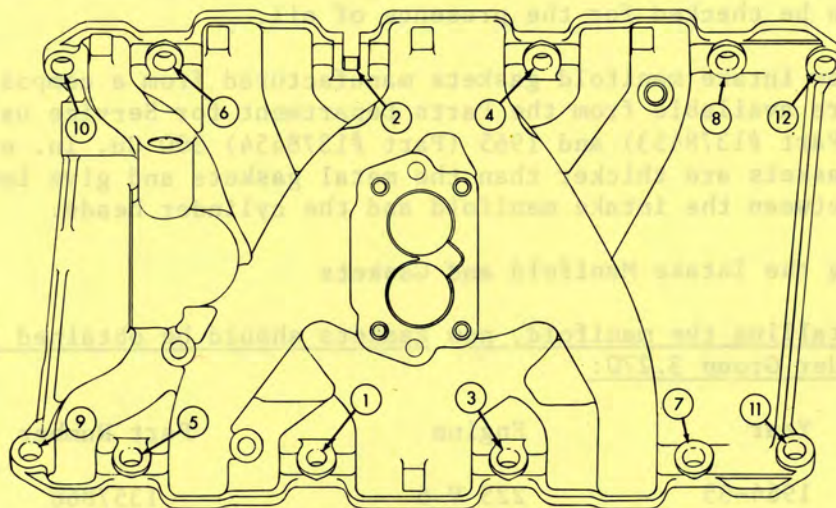
FIGURE 2

2 & 4 BARREL V-8 INTAKE MANIFOLD  
(300 ENGINE) BOLT TIGHTENING SEQUENCE

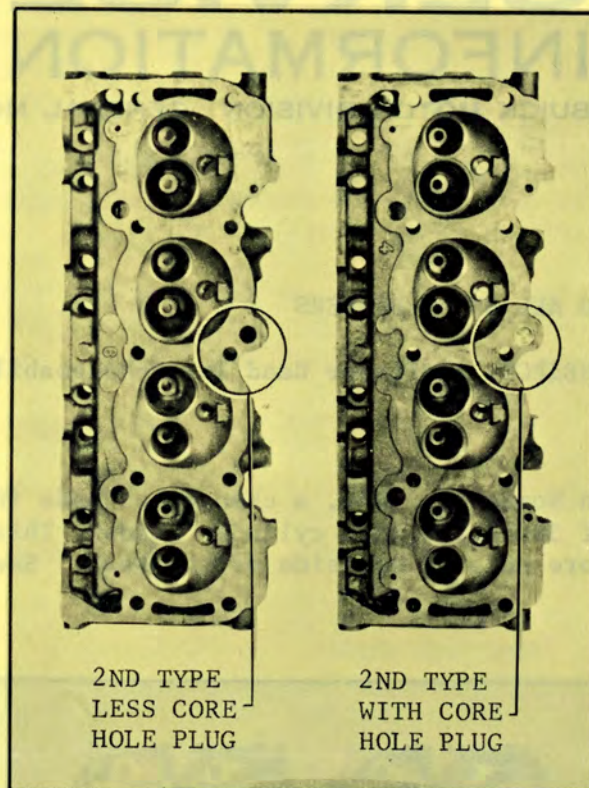
FIGURE 4

Due to the fact that the cylinder head change was completed before the cylinder blocks and head gaskets were modified, some engines were built using the second type heads with first type blocks and gaskets. This was accomplished by plugging the core holes in the heads as illustrated in Figure 4.

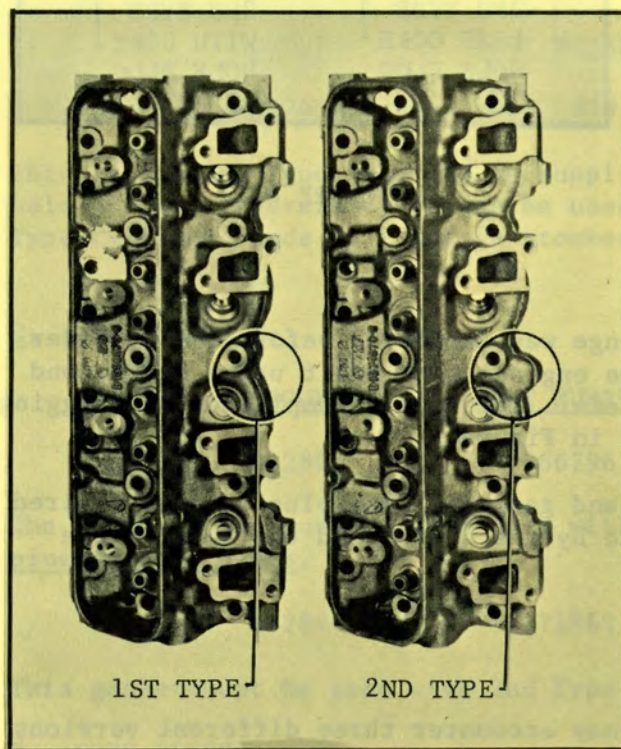
FIGURE 1

In November, 1964, a change was made in production to facilitate the manufacture of 300 cubic inch cylinder heads. This change consisted of the addition of a core hole to one side of the head. See Figure 1.

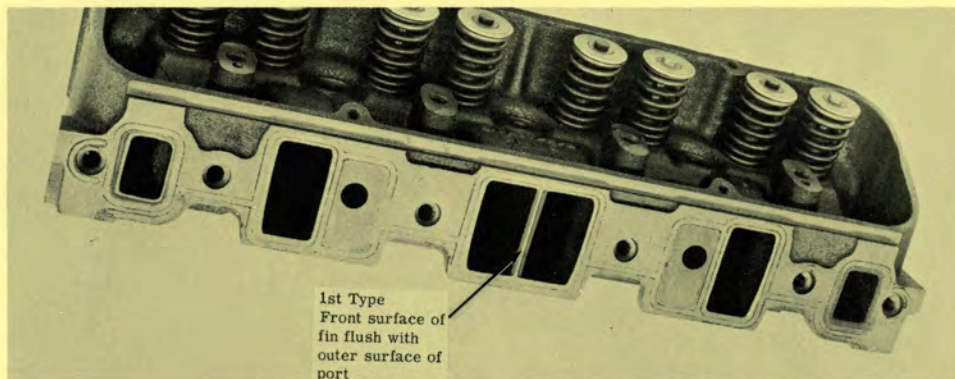
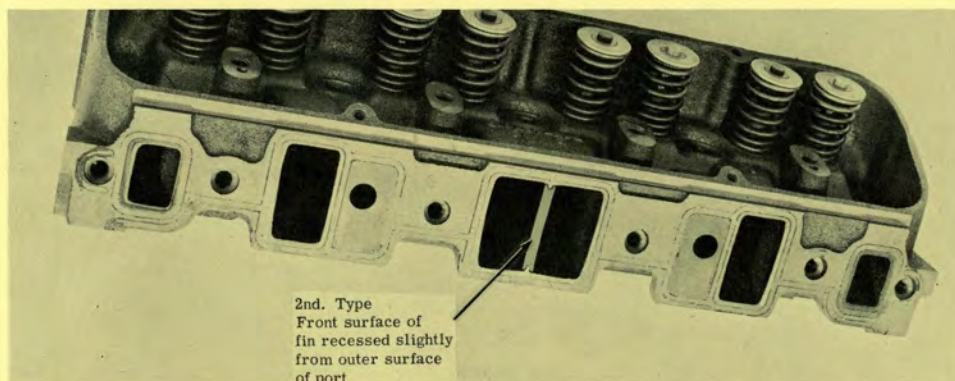
Because of a manufacturing revision in 300 cu. in. engine cylinder heads, many dealers are replacing supposedly defective heads in their efforts to correct intake manifold gasket leaks. The thin web between the two center intake ports may appear to be broken off or recessed back too far to effect a seal between the head and the intake manifold. See illustration of 2nd type. Actually, the web has been recessed to facilitate machining operations in this area. The location of the web does not affect the seal between the intake manifold and the cylinder head and has no adverse effect on engine operation.

Refer to Dealer Letter No. 65-87A for replacement procedures for intake manifold gaskets.

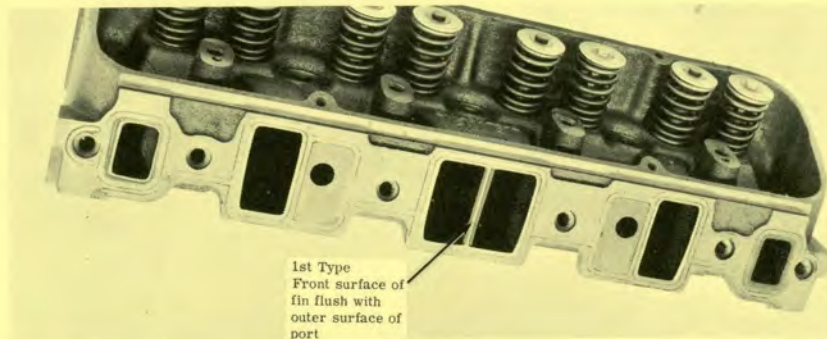
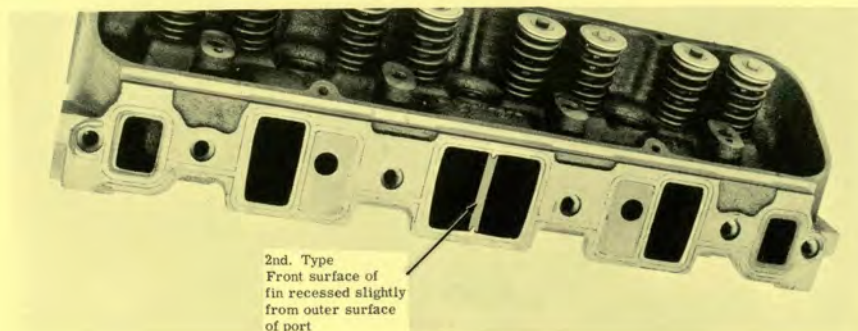
Because of a manufacturing revision in 300 cu. in. engine cylinder heads, many dealers are replacing supposedly defective heads in their efforts to correct intake manifold gasket leaks. The thin web between the two center intake ports may appear to be broken off or recessed back too far to effect a seal between the head and the intake manifold. See illustration of 2nd type. Actually, the web has been purposely recessed to facilitate machining operations in this area. The recessed web does not contribute to leaks between the intake manifold and the cylinder head and has no adverse effect on oil consumption or engine performance.

Effective immediately AFA's will not be accepted for replacement of revised cylinder heads unless approved by the Zone Service Manager.

Refer to Dealer Letter No. 65-87B for replacement procedures for new type intake manifold gaskets.

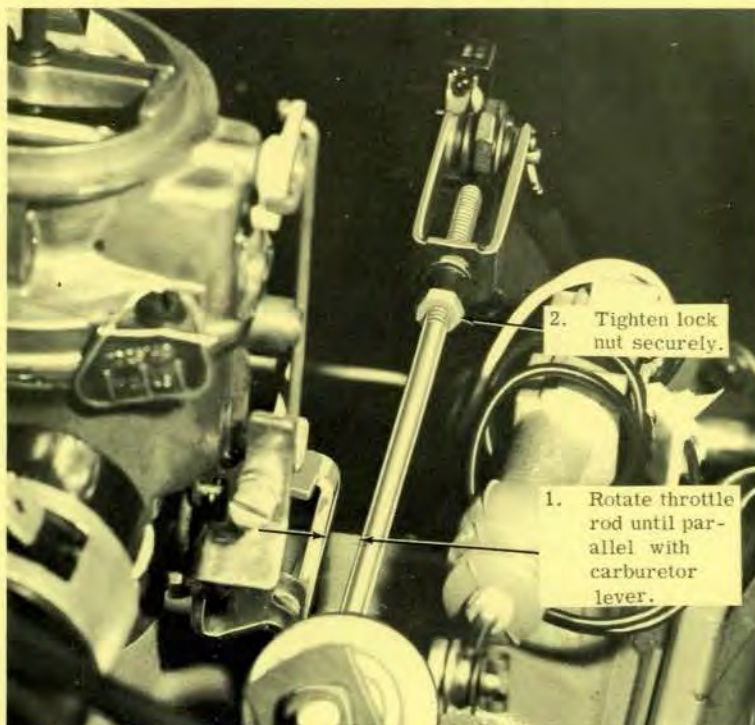
SUBJECT: Bind in Throttle Linkage - 1965 V-6 Engine

On all single barrel carburetor equipped V-6 engines, make certain the throttle operating rod is installed as shown in the illustration. This rod is curved, and it is possible that the curved portion of the rod may be positioned toward the carburetor causing contact at the carburetor throttle lever. To insure free travel, make certain rod is installed as shown in the illustration on all V-6 engines prior to owner delivery. Please add this operation to the new car Pre-delivery Inspection Schedule.

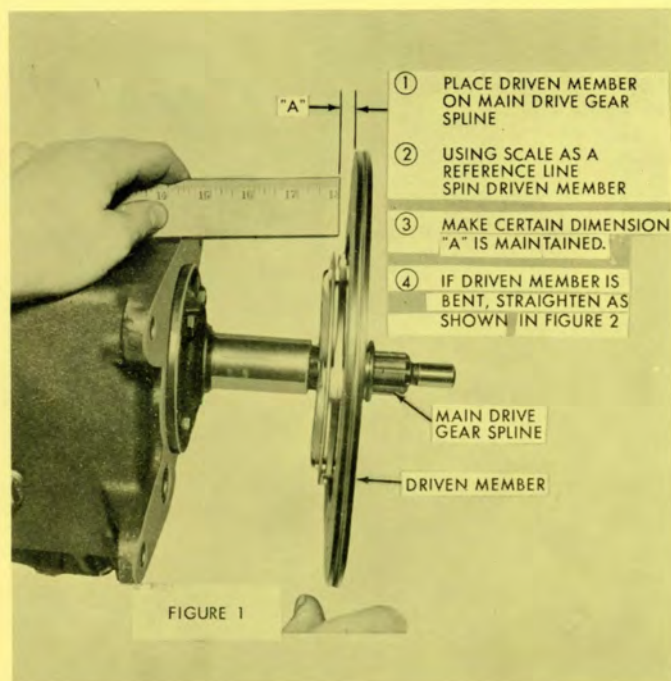
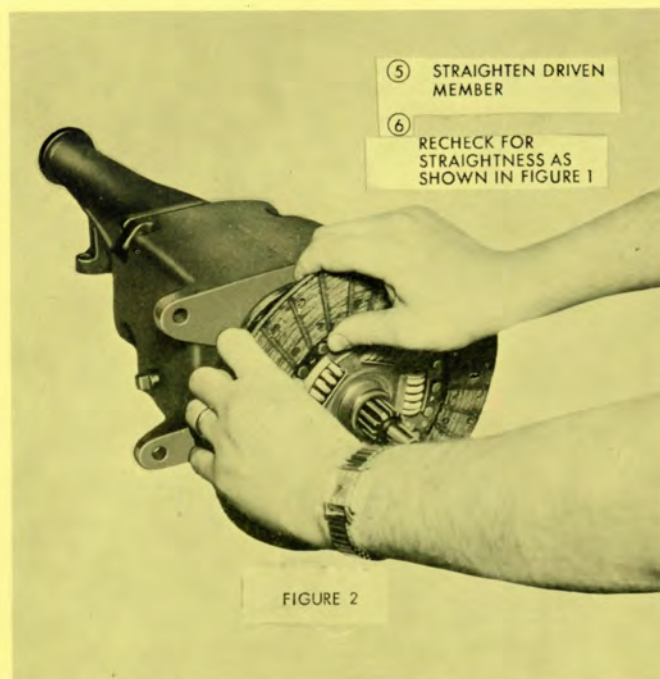
Many times a clutch driven member is replaced due to excessive run-out. If a case is encountered where excessive run-out exists, it is recommended that the driven member be straightened as shown in figures 1 and 2.

NOTE: Extreme care must be taken not to get grease or oil on clutch driven member.

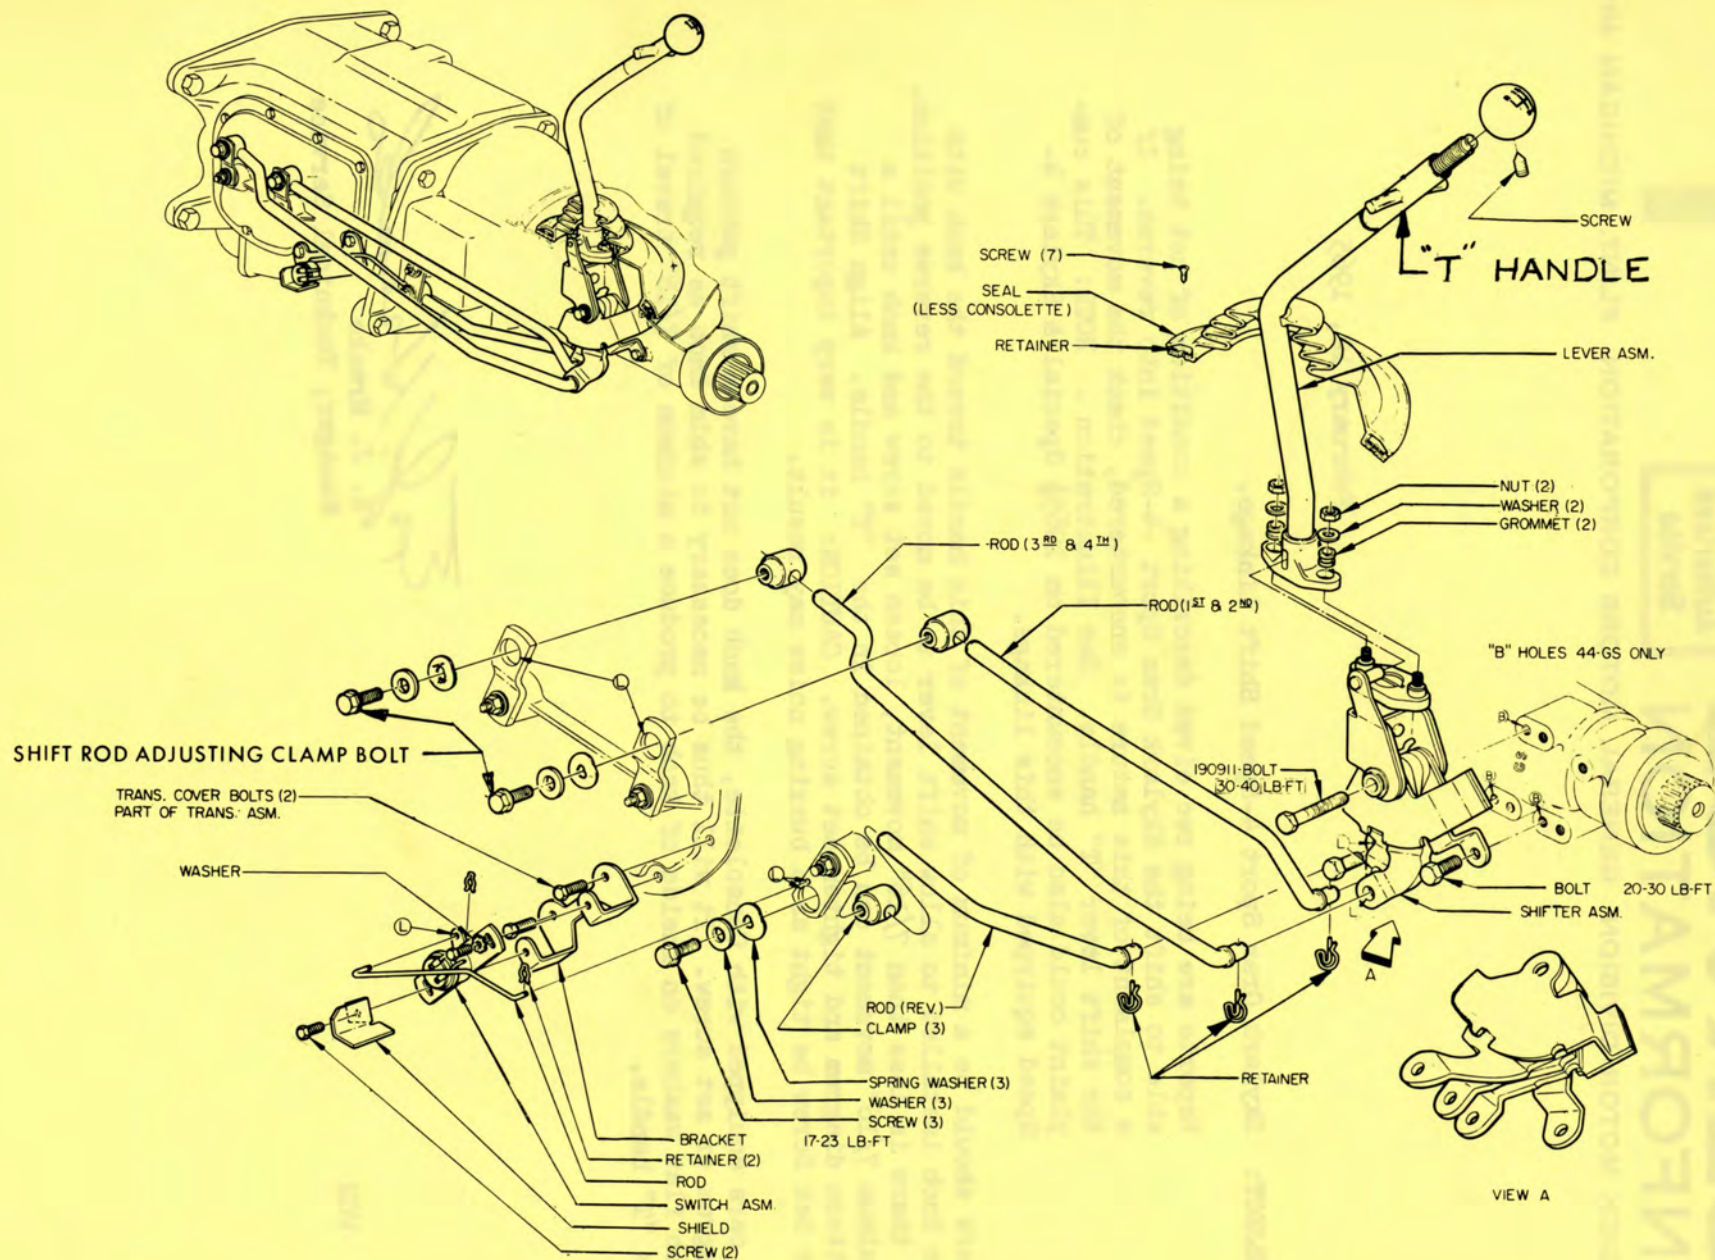
Reports are being received describing a condition of not being able to shift the Skylark Gran Sport 4-Speed into reverse. If a complaint of this nature is encountered, check the movement of the shift lever "T" handle. See Illustration. NOTE: This complaint could also be encountered on 1965 $\frac{1}{2}$  Special & Skylark 4-Speed equipped with this linkage.

There should be a minimum of movement of this handle toward the knob with the knob installed to allow shift lever to be moved to the reverse position. If there is less than  $\frac{7}{16}$ " movement, loosen set screw and knob until a minimum  $\frac{7}{16}$ " movement can be obtained in the "T" handle. Align Shift Pattern diagram and tighten set screw. CAUTION: it is very important that the Set Screw be tight as a buzzing noise may result.

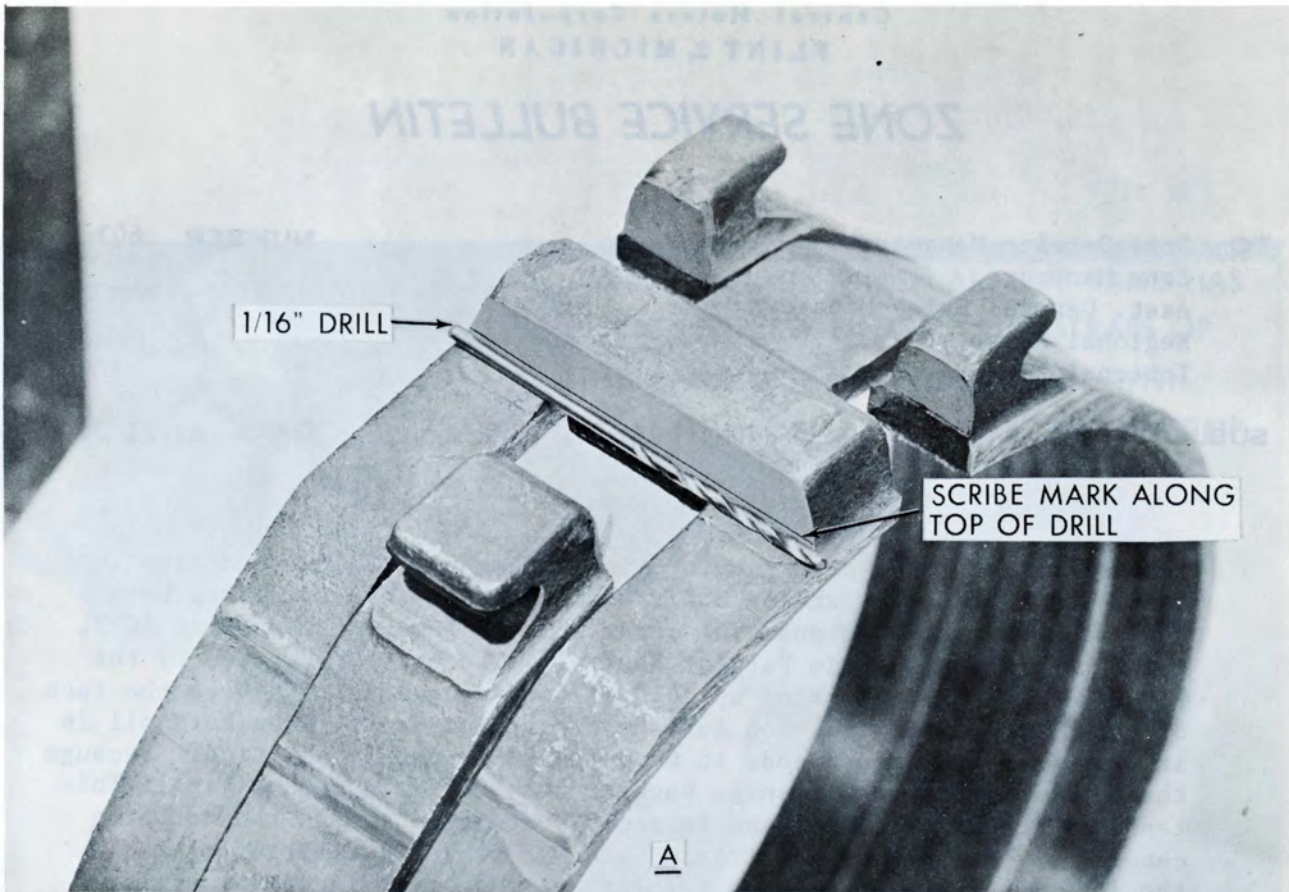
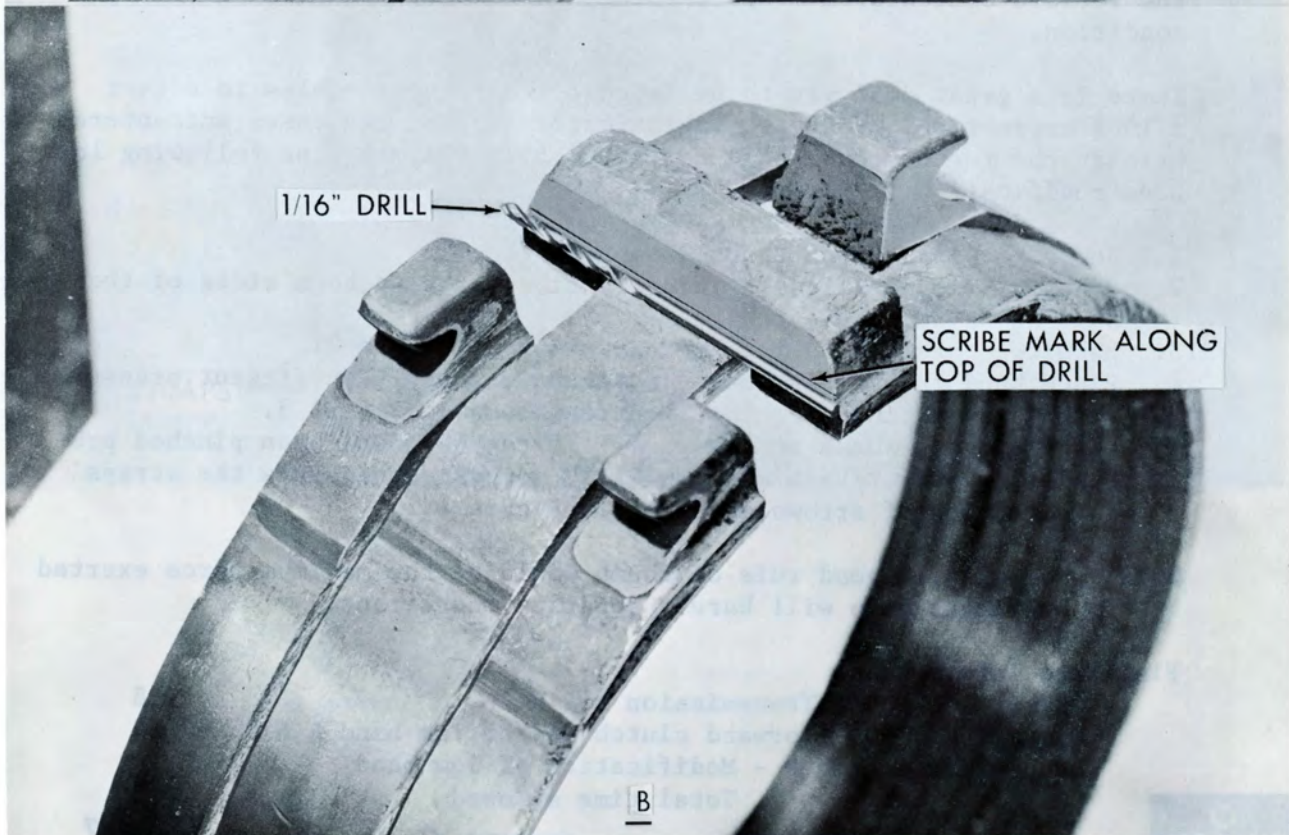
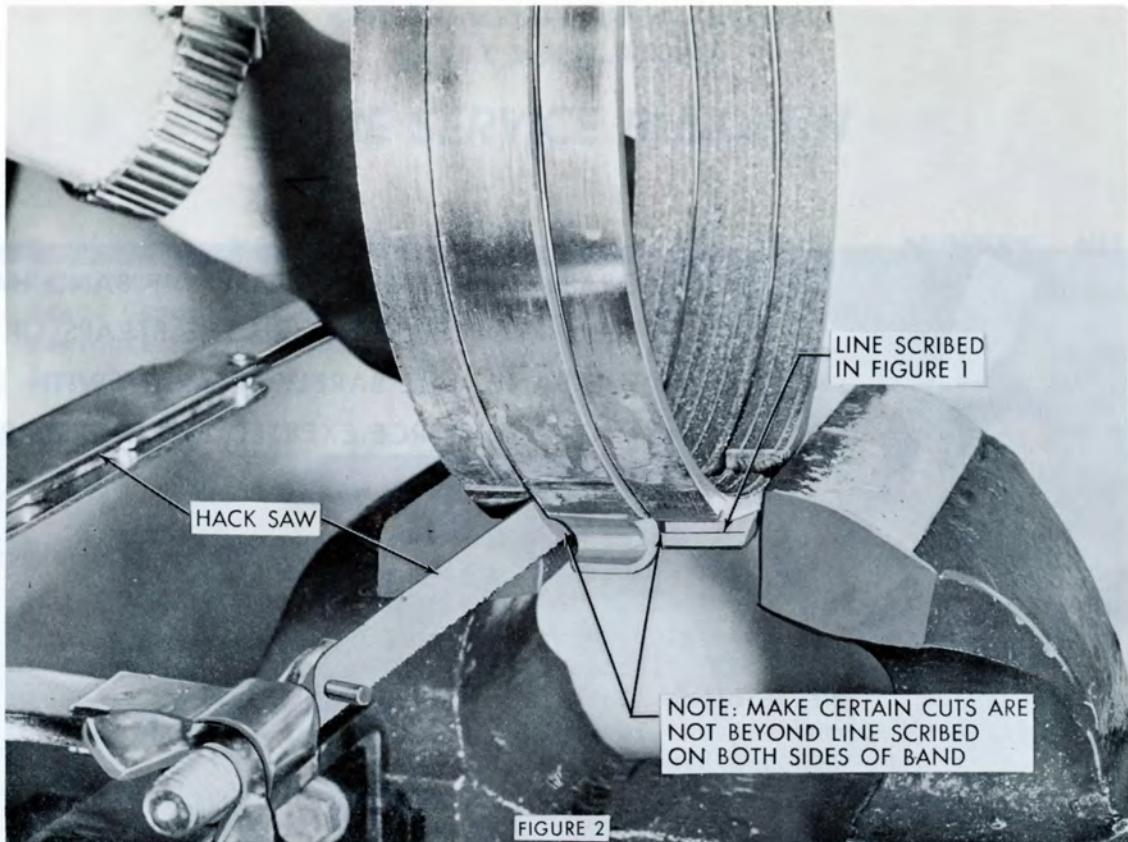
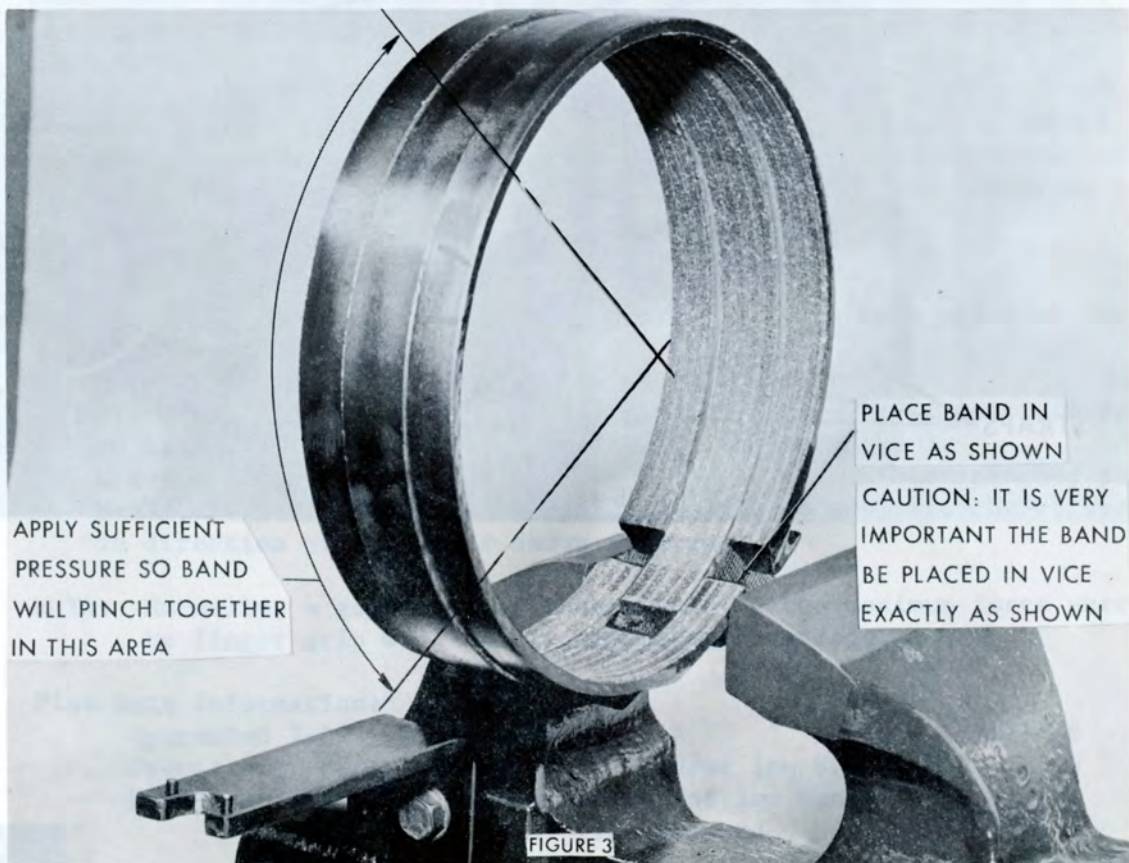
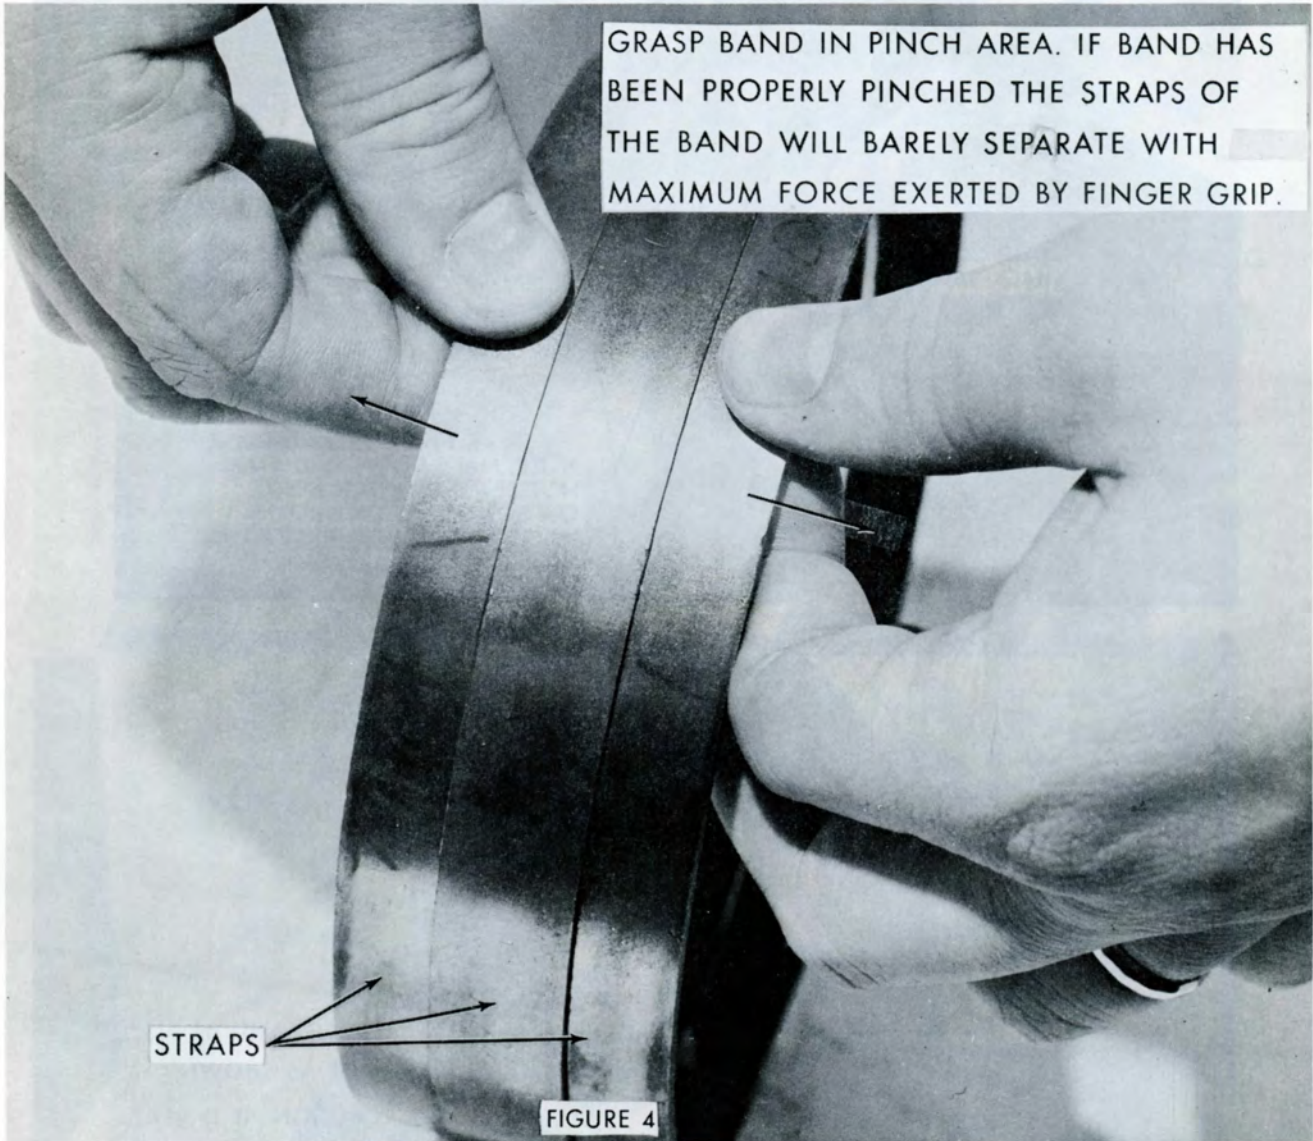
Several reports have been received indicating a rattling condition exists on some Super Turbine 300 transmissions. This noise has been traced to the low band and will occur only at temperatures below 40°F, with the transmission in Park or Neutral. The noise is caused by the forward clutch drum picking up cold oil and dragging it between the face of the drum and the friction surface of the low band. When cold oil is in this area, the band tends to move toward the apply position. Because the band is anchored, it snaps back to its full release position. This tendency to apply and release in rapid succession causes the rattling condition. As soon as the transmission is placed into Drive or Low, the forward clutch drum stops turning, thus eliminating the rattling condition.

GRASP BAND IN PINCH AREA. IF BAND HAS BEEN PROPERLY PINCHED THE STRAPS OF THE BAND WILL BARELY SEPARATE WITH MAXIMUM FORCE EXERTED BY FINGER GRIP.

1. Remove low band from transmission.
2. Using a 1/16" drill as a guide, scribe marks on both sides of the band as shown in Figure 1.
3. Make two cuts in the low band as shown in Figure 2.
4. Place band in vise as shown in Figure 3. Apply sufficient pressure so band will pinch together in area shown in Figure 3.
5. Grasp band as shown in Figure 4. If the band has been pinched properly, it will take a minimum of 10 pounds to separate the straps in direction of arrows as shown in Figure 4.

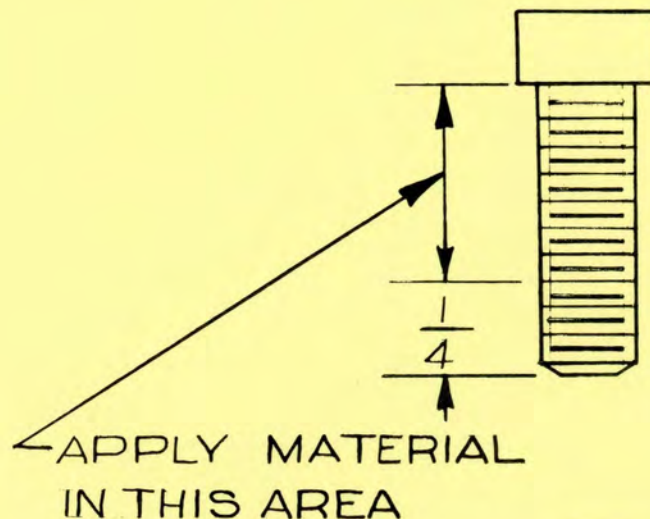
The case to case center support bolt is designed to have an interference thread engagement. It has been found that on repeat disassemblies, this interference engagement is reduced. A failure would occur if the bolt should become loose.

It is recommended that a material like Lok-Tite (Type "AV" or "AA") or equivalent be used on the bolt when reassembling.

The mating parts should be absolutely clean and the material applied on the bolt threads  $\frac{1}{4}$ " above the lead thread. See illustration below.

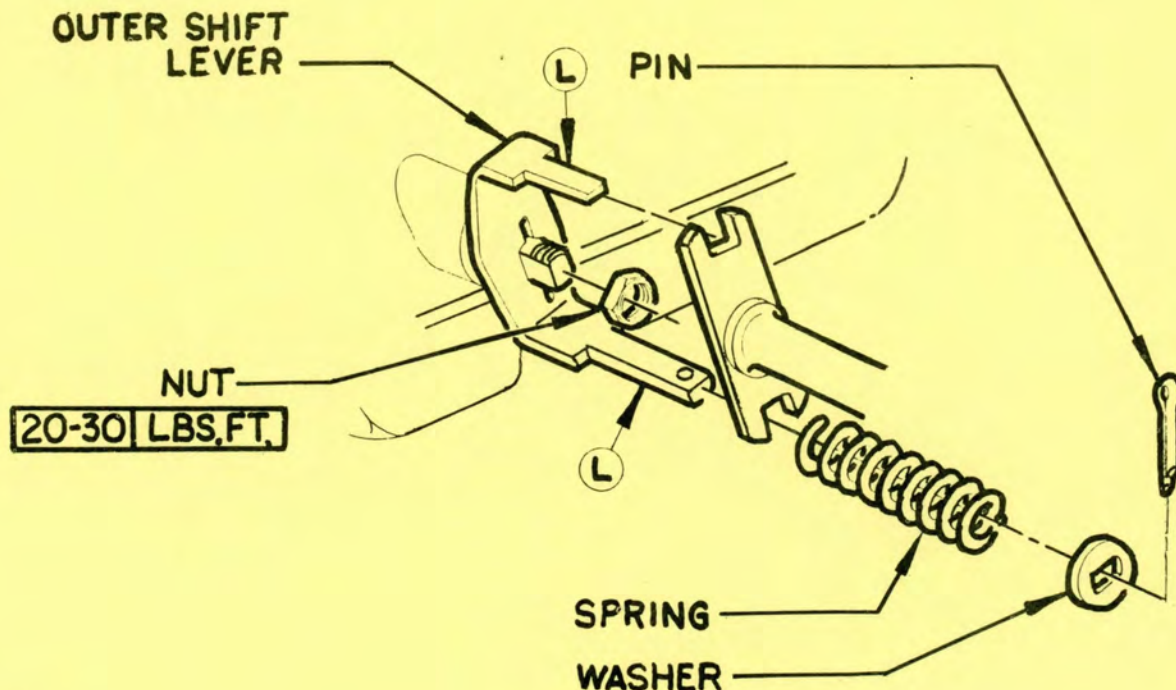
It is recommended that, on all Super Turbine 300 and 400 transmissions, the outer shift lever nut not be tightened with an impact wrench. There is a possibility that the inside manual linkage parts can become damaged by over-torquing.

CAUTION: Hold shift lever while tightening nut to prevent valve body damage.

Torque the outer shift lever nut, on both the Super Turbine 300 and 400 transmissions, to 20-30 ft. obs.

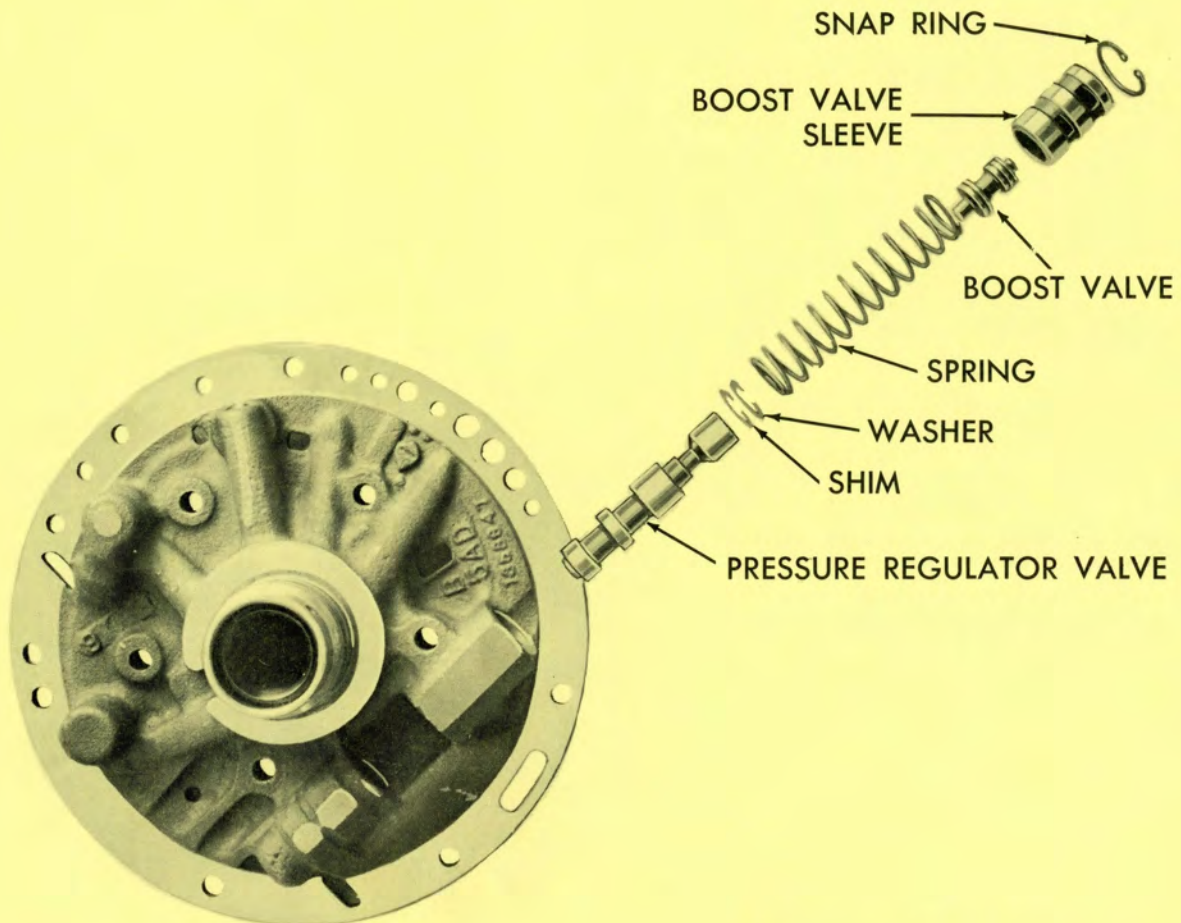
In the 1965 Chassis Service manuals, Special and Upper Series, the Pressure regulator valve is shown out of position in figures 5-193 and 5-203. The valve should be in the position shown in illustration below.

This correction should be noted in your 1965 Service manuals.

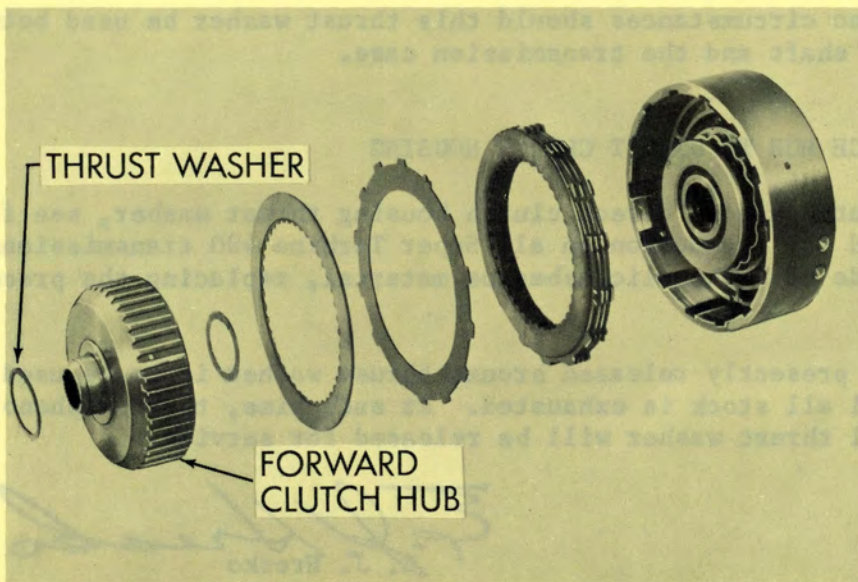
FIGURE 3

A new forward clutch hub to direct clutch housing thrust washer, see figure 3, has been released for production on all Super Turbine 400 transmissions. The new washer is made of a phenolic asbestos material, replacing the present bronze washer.

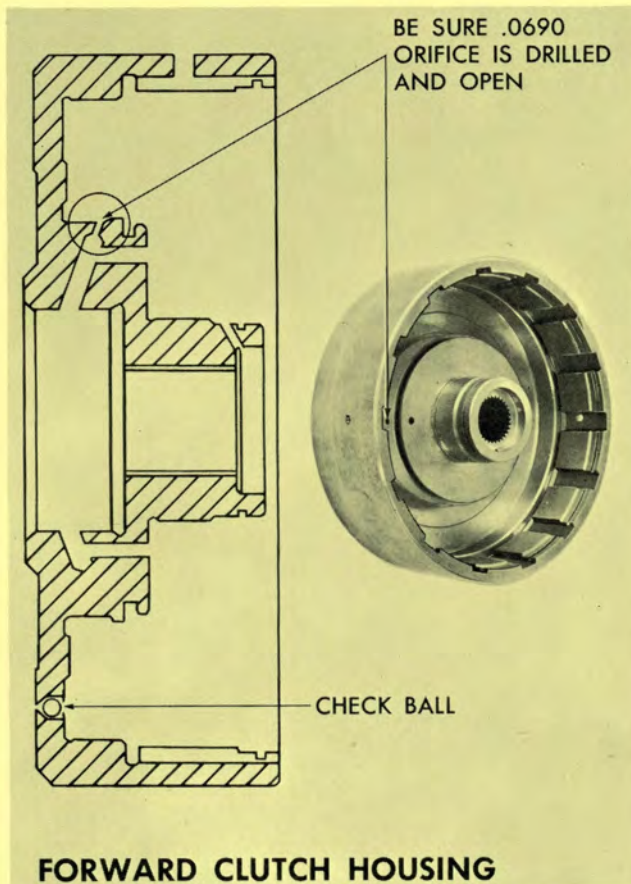
SUBJECT: Super Turbine 400 Transmission Forward Clutch Failure

If a forward clutch failure is encountered in a Super Turbine 400 transmission, it is very important that the forward clutch feed orifice (see figure 1) be checked for being blocked or partially restricted. It is recommended that a small wire be inserted through this feed orifice to make certain it is open. There is a possibility that a limited number of 1965 transmissions were built without the feed orifice drilled. If a case is encountered where the feed orifice was not drilled, a new forward clutch housing, Group 4.169, Part No. 8623791, must be installed.

NOTE: A failure caused by feed orifice not drilled will be an early failure.

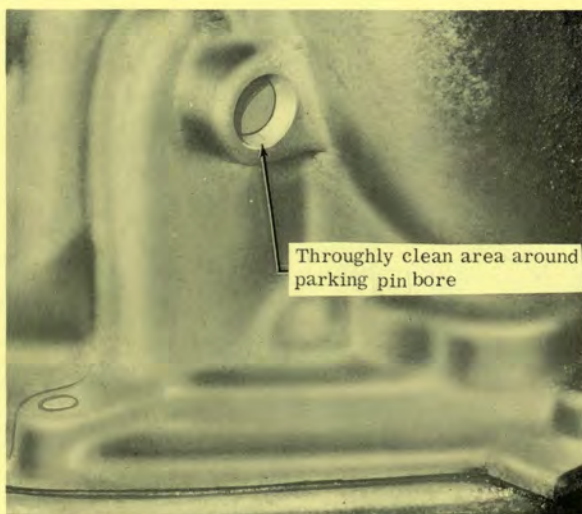
FIGURE 1

If an oil leak is encountered on a Super Turbine 400 transmission at the parking pin bore, it can be repaired with the transmission in the car by using the following procedure:

1. Raise car on a hoist or jack stand; thoroughly clean area around parking pin bore (See Figure 1) with a cleaning solvent and brush; air dry.
2. Apply small quantity of Special Thread Sealer and Lube, Group 8.800, Part No. 1050026 or equivalent to a .38 diameter cup plug, Group 4.294, Part No. 8620318.
3. Position cup plug with open end facing front of transmission. See Figure 2.
4. Using a 3/8" diameter rod, drive plug into parking pin bore until it is flush with case.
