# 1965 BUICK DEALER SERVICE INFORMATION LETTER INDEX

Through November 30, 1965

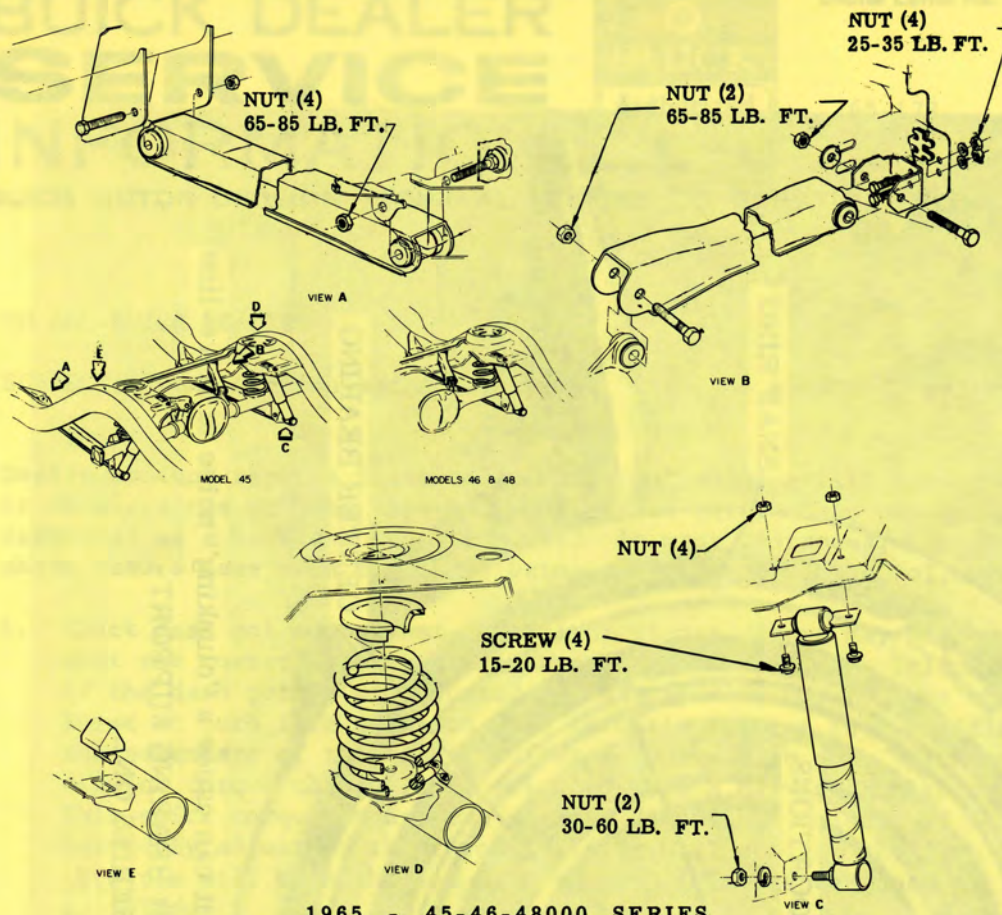
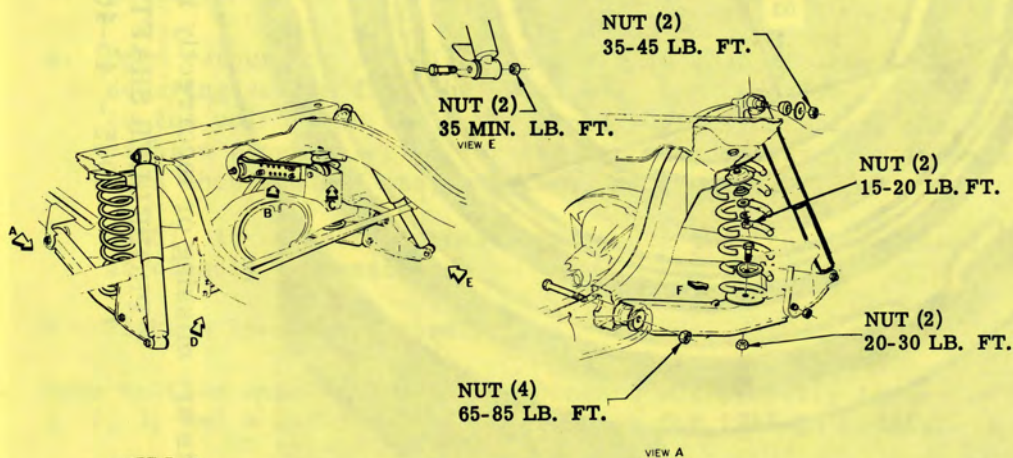
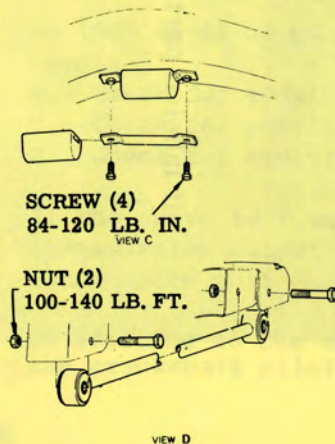
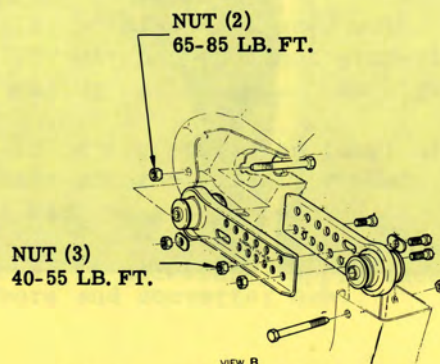
If labeled parts are missing or incorrectly installed it can cause a "clunking" noise in drive-line

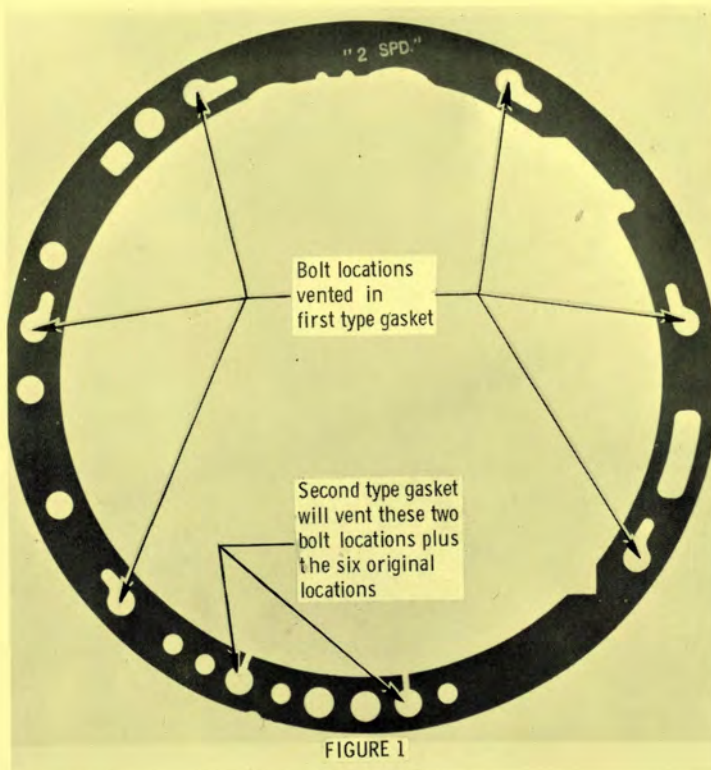
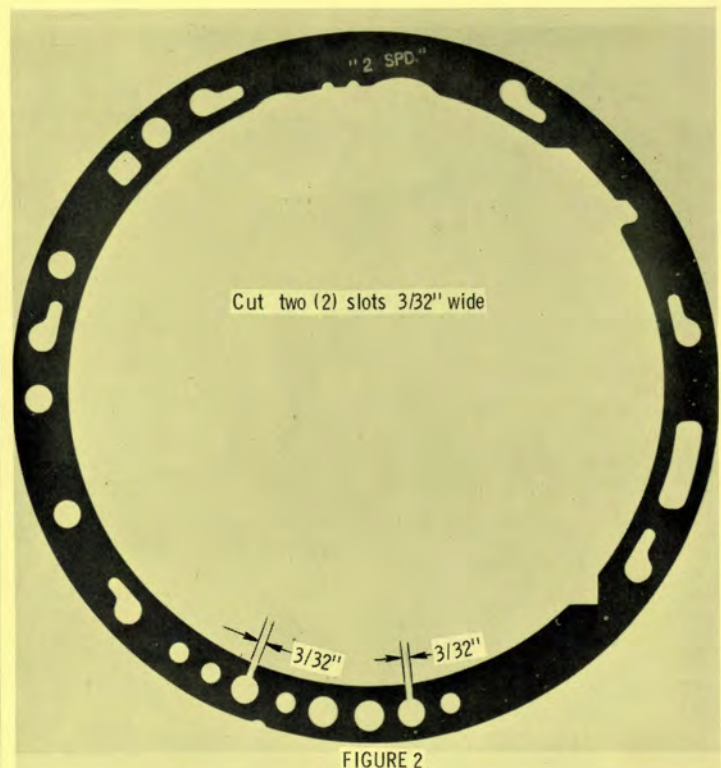
Starting with 1965 transmission code number 214, a revised pump to case gasket went into production on all Super Turbine 300 transmissions. The gasket used before transmission code number 214 provided for venting six of the eight pump to case attaching bolts. The new gasket provides venting for the remaining two locations. See figure 1. Because of space limitations, the additional two bolt holes are vented with radical cuts rather than elongated slots. Venting the attaching bolt locations reduces the possibility of an oil leak in this area.

Before installing a first type service gasket, it should be modified as shown in figure 2.

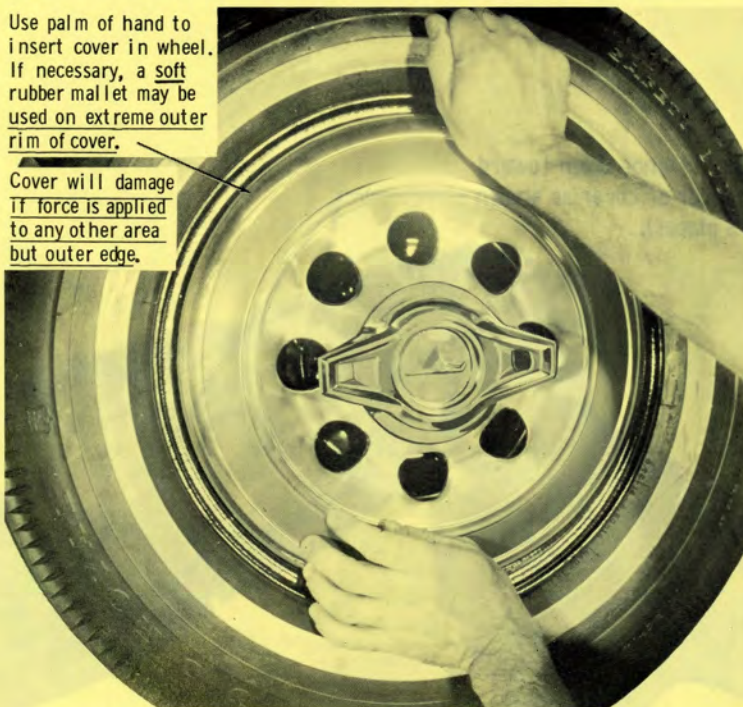
FIGURE 1

Cover will damage if force is applied to any other area but outer edge.

Use palm of hand to insert cover in wheel. If necessary, a soft rubber mallet may be used on extreme outer rim of cover.

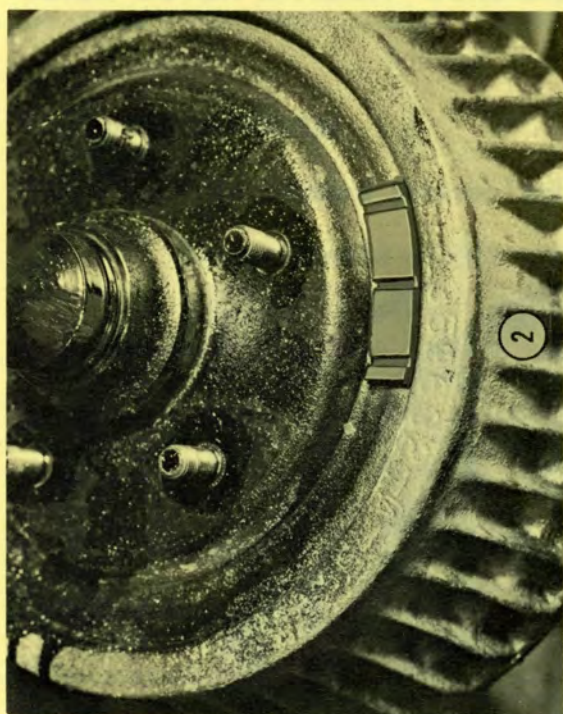
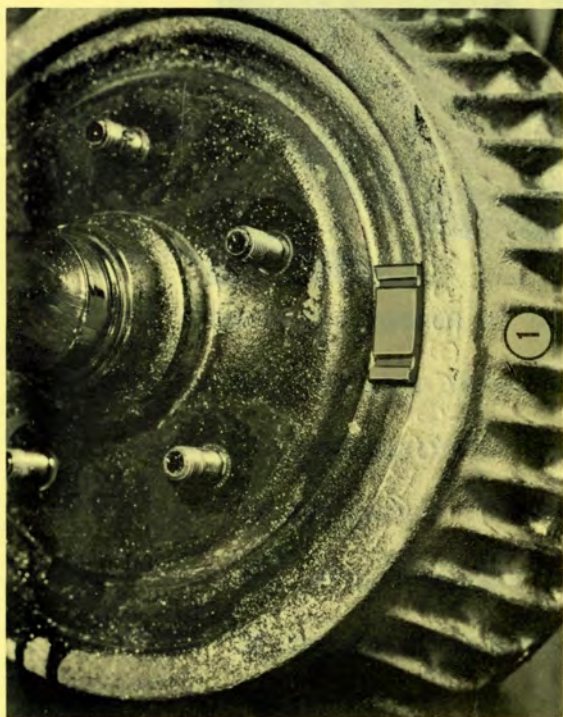
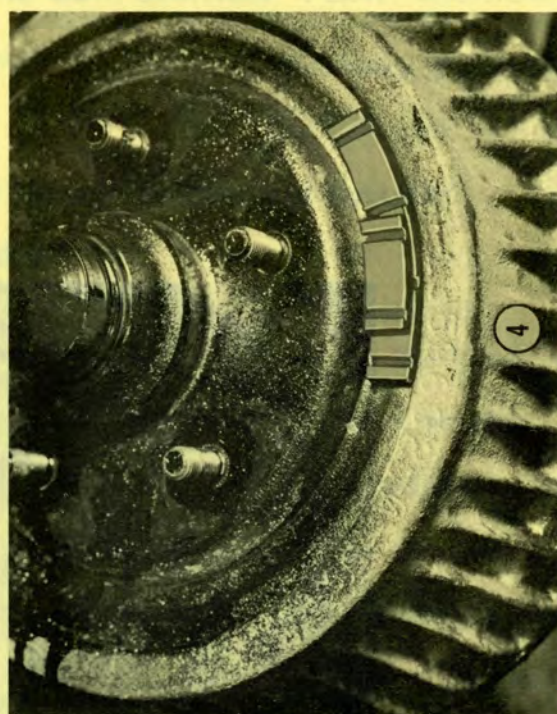
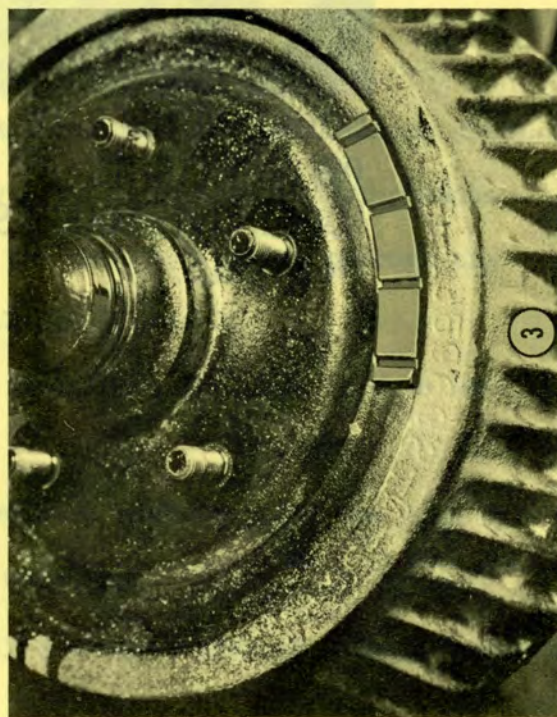
FIGURE 1

The Engineering Department, advised us that a small percentage of the brake drums used on Specials and Skylarks will have two layers of balance weights as shown in Figure 1. When a drum balanced in this manner is installed on a car equipped with optional chrome-plated wheels, it is possible that an interference condition may exist between the wheel and the balance weight. This interference will not permit the wheel to seat properly and could cause car shake, improper tracking, tire wear, and etc.

DRUMS BALANCED WITH ONE LAYER OF WEIGHTS AS SHOWN IN 1, 2, AND 3, CAN BE USED WITH CHROME WHEELS.

DO NOT USE WITH CHROME WHEELS

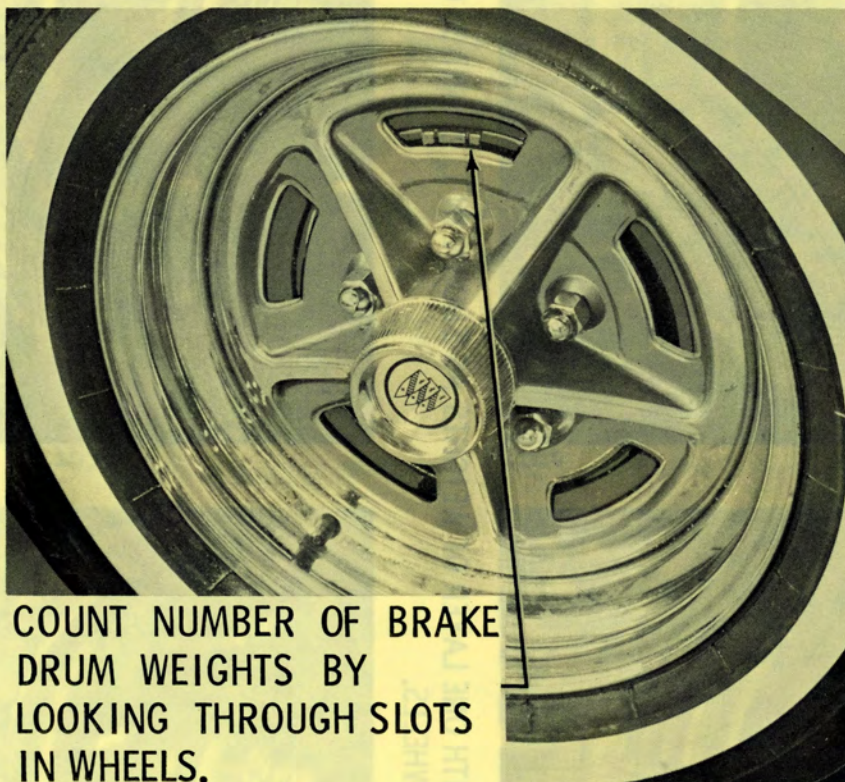
FIGURE 2

COUNT NUMBER OF BRAKE  
DRUM WEIGHTS BY  
LOOKING THROUGH SLOTS  
IN WHEELS.

1. Note the number of balance weights on the drum by looking through the slots between the spokes of the wheel. See Figure 2.
2. If two or more weights have been used to balance the drum, remove wheel and check for two layers of weights.
  - A. If two layers of weights have been used, replace the drum with one using a single layer of weights.
  - B. If the original drum has only a single layer of weight, re-install wheel.

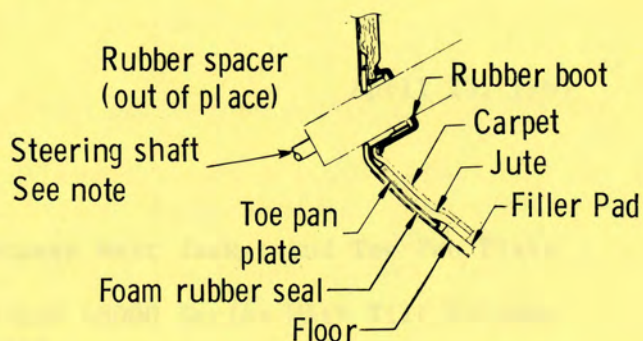
NOTE: When rubber spacer is out of place, mast jacket becomes misaligned causing steering shaft to rub against shift tube. Binding or squeaking may result.

Mast jacket misaligned - spacer out of position - 45000, 46000 & 48000 series - tilt columns only

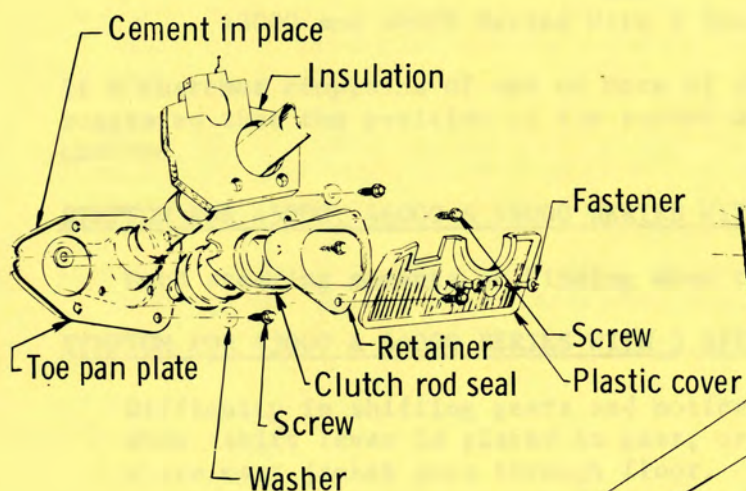
43000 & 44000 series only

On 43000 & 44000 Series cars the difficulty in shifting and excessive steering wheel shake is again a result of a lack of support at the lower end of the mast jacket, and is caused by the rubber spacer being incorrectly located. Under these circumstances, a large part of the support of the lower end of the mast jacket is transferred to the flexible coupling (rag joint coupling). Also to a limited extent, the stress of support is transferred to the shift linkage, and this creates the possibility of binding.

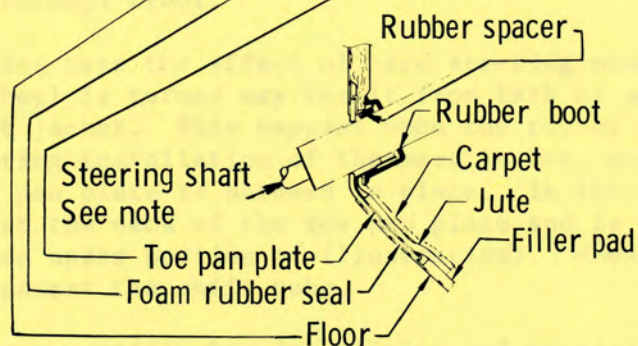
Mast jacket correctly aligned - spacer in position - 45000, 46000 & 48000 series - tilt columns only

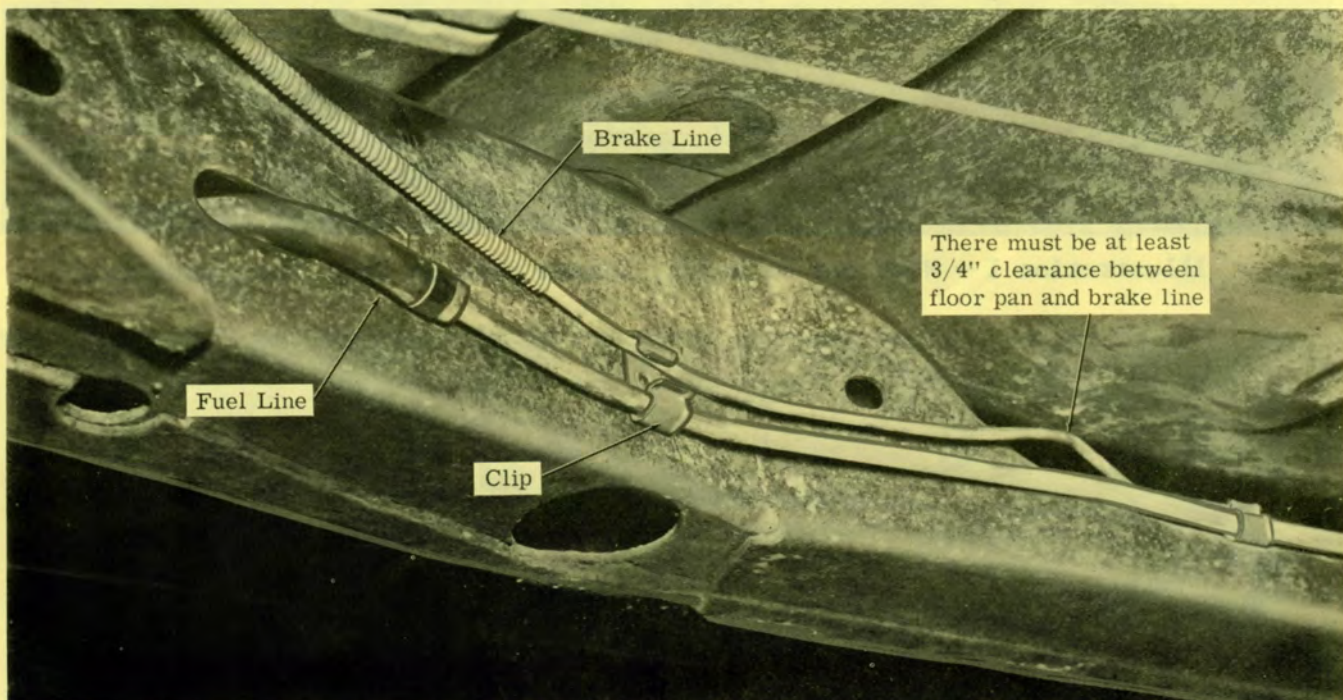
- B. Inspect all brake lines to be sure they are properly installed in clips and for any possible wearing contact, especially in the area on the left frame side rail. (There should be five clips, including one just installed, retaining line to frame rail.) Provide clearance from area of contact. There must be at least 3/4" clearance between floor pan and brake line at all areas along left frame side rail. If a line has loss of metal due to rubbing, brake line must be replaced.

Illustration 4 - Secure brake line and fuel line into clip.

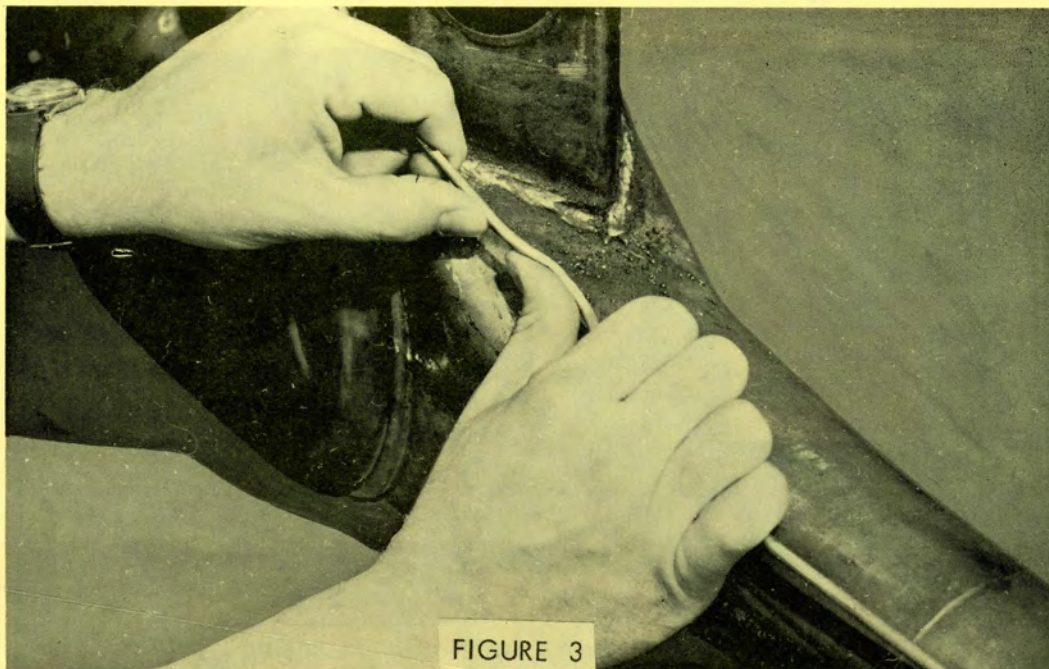
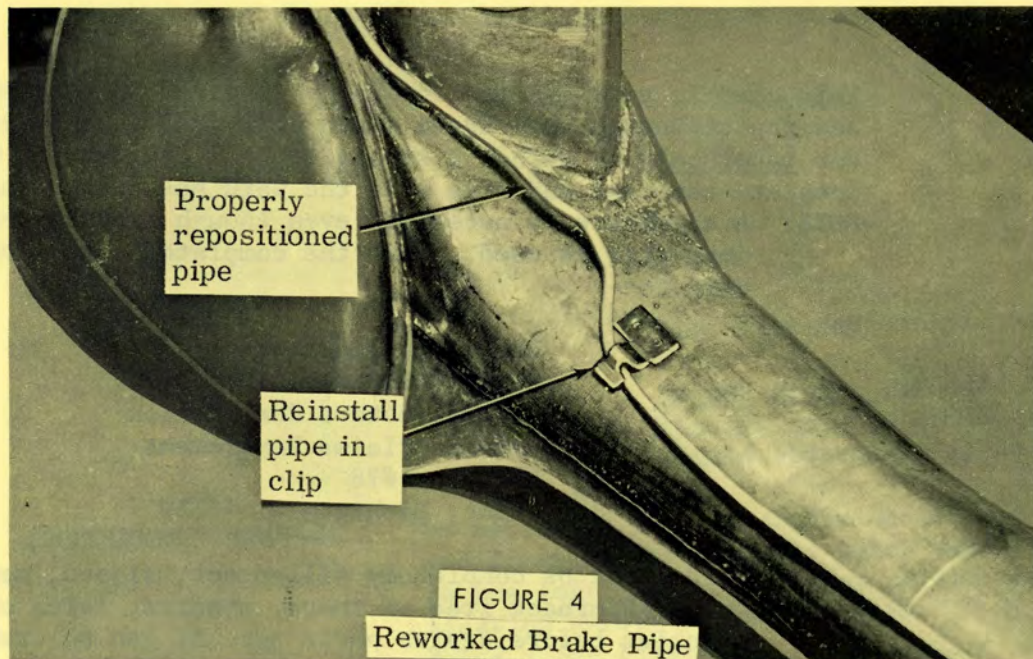
If there are signs of repeated contact, the brake pipe must be replaced with the late type which has a different shape.

1. Pry up clip to disengage pipe. See Figure 2.  
Bend pipe or pipes forward against axle housing and re-engage in clip. See Figures 3 and 4.  
Bend clip down to original position to firmly hold pipe against axle housing.

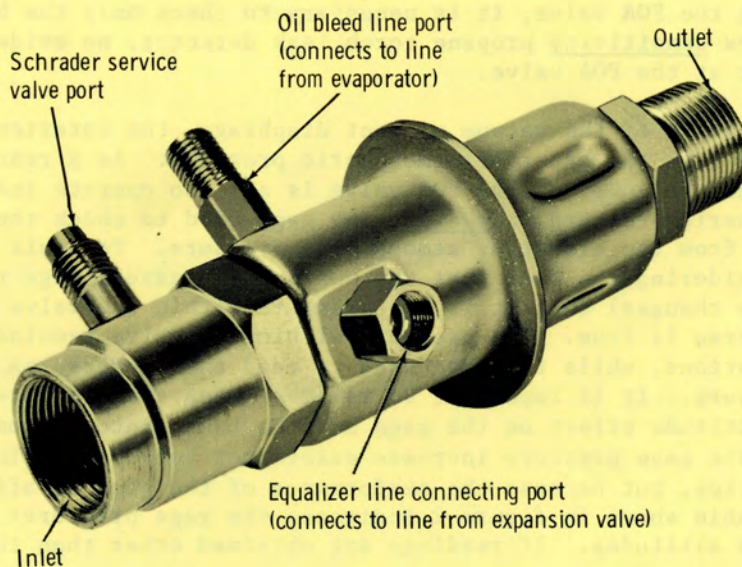
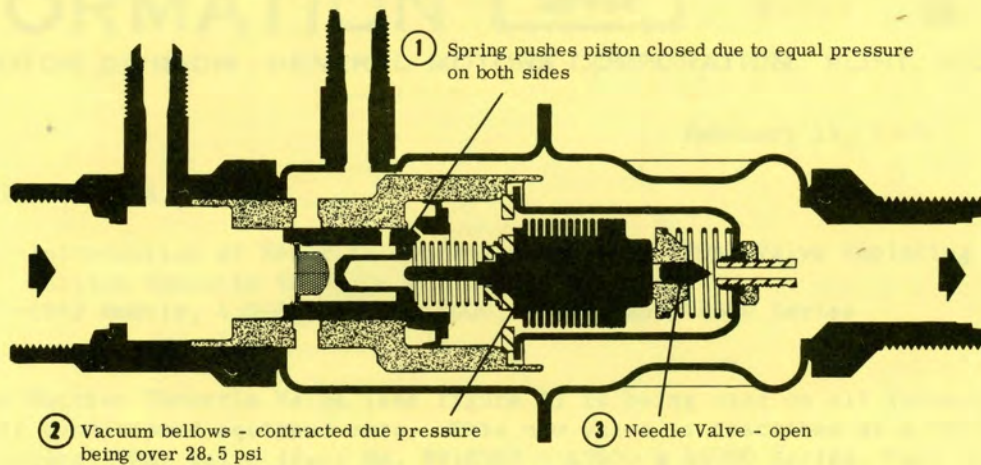
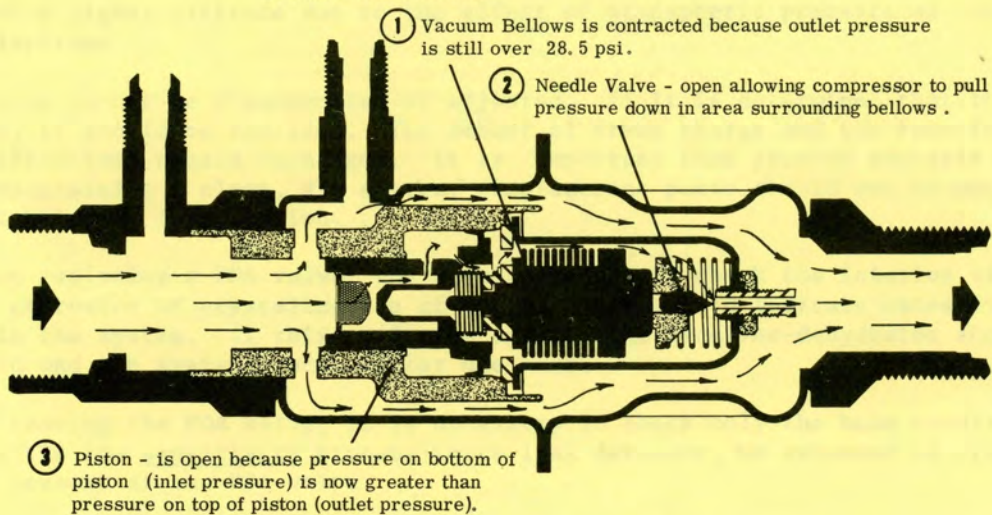
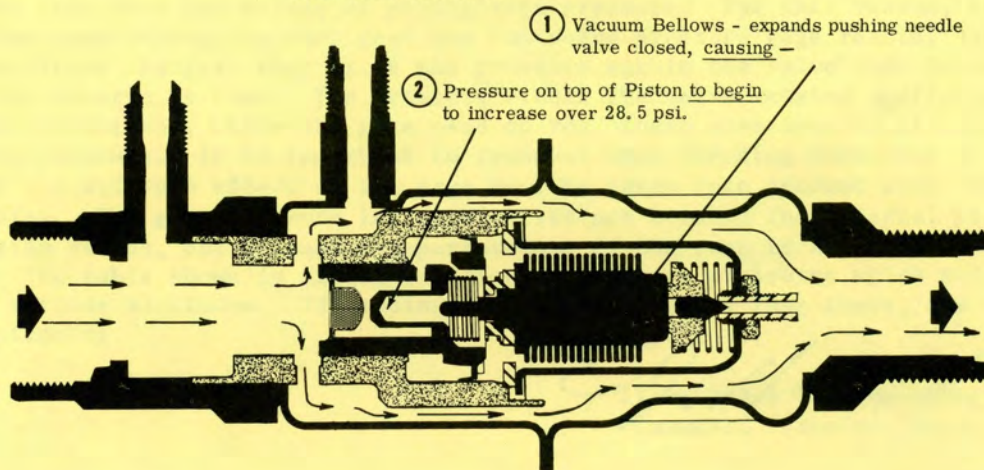
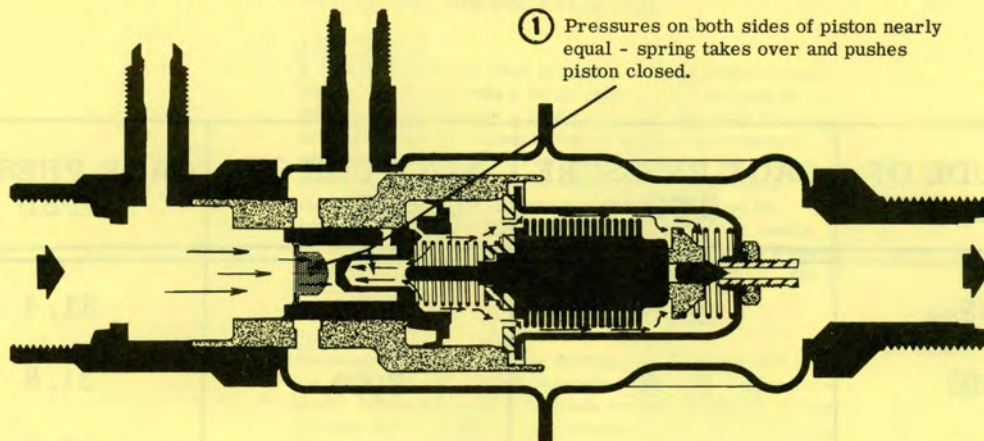
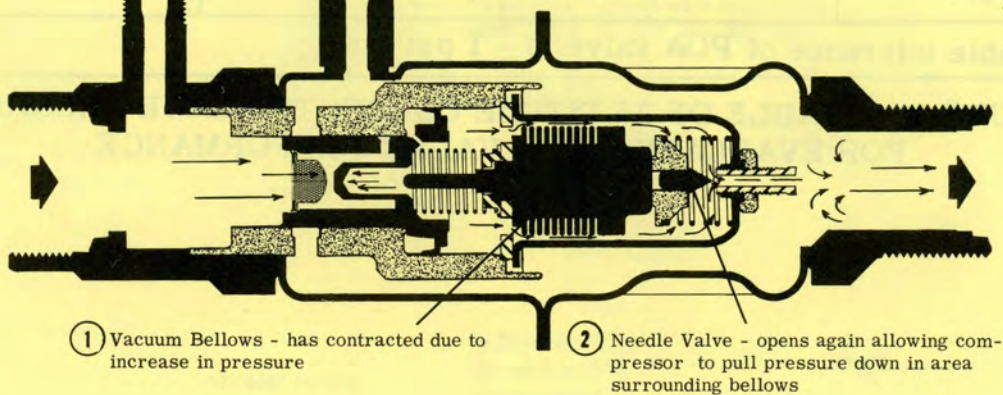
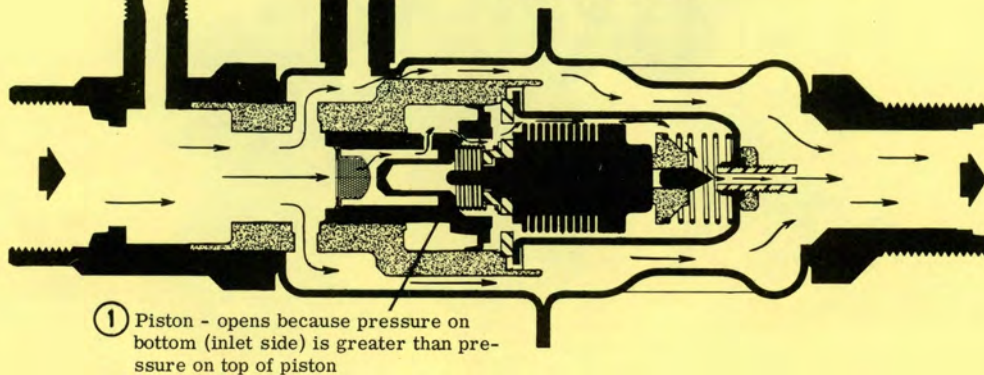
FIGURE 1 POA VALVE S

A new type Suction Throttle Valve (see figure 1) is being used on all (except 49000 Series) air conditioned equipped cars. This new valve is described as a Pilot Operated Absolute (POA) valve (Part No. 5910508 - 43000 & 44000 Series, Part No 5910521 45000, 46000, 48000 Series, Group 9.198).

The difference between the STV and the POA valve is that no neoprene or vacuum element diaphragms are used. The advantages are that there is no neoprene diaphragm which might fail, and that the valve will not change calibration when the system is operated at a higher altitude due to the effect of atmospheric pressure on the vacuum element diaphragm.

NOTE: When replacing a POA valve, the serviceman should check the interior of the valve for corrosion or crystalization of salts. This should indicate excessive moisture in the system. If this condition exists, the receiver-dehydrator should be replaced and the system evacuated for one hour.

The POA valve cannot be disassembled or adjusted. If it is determined that the POA has failed, it should be replaced. The amount of freon charge and the functional test specifications remain unchanged. It is important that greater emphasis be given to maintaining a clean, dry system. Replacement parts should not be uncapped until just prior to installation.

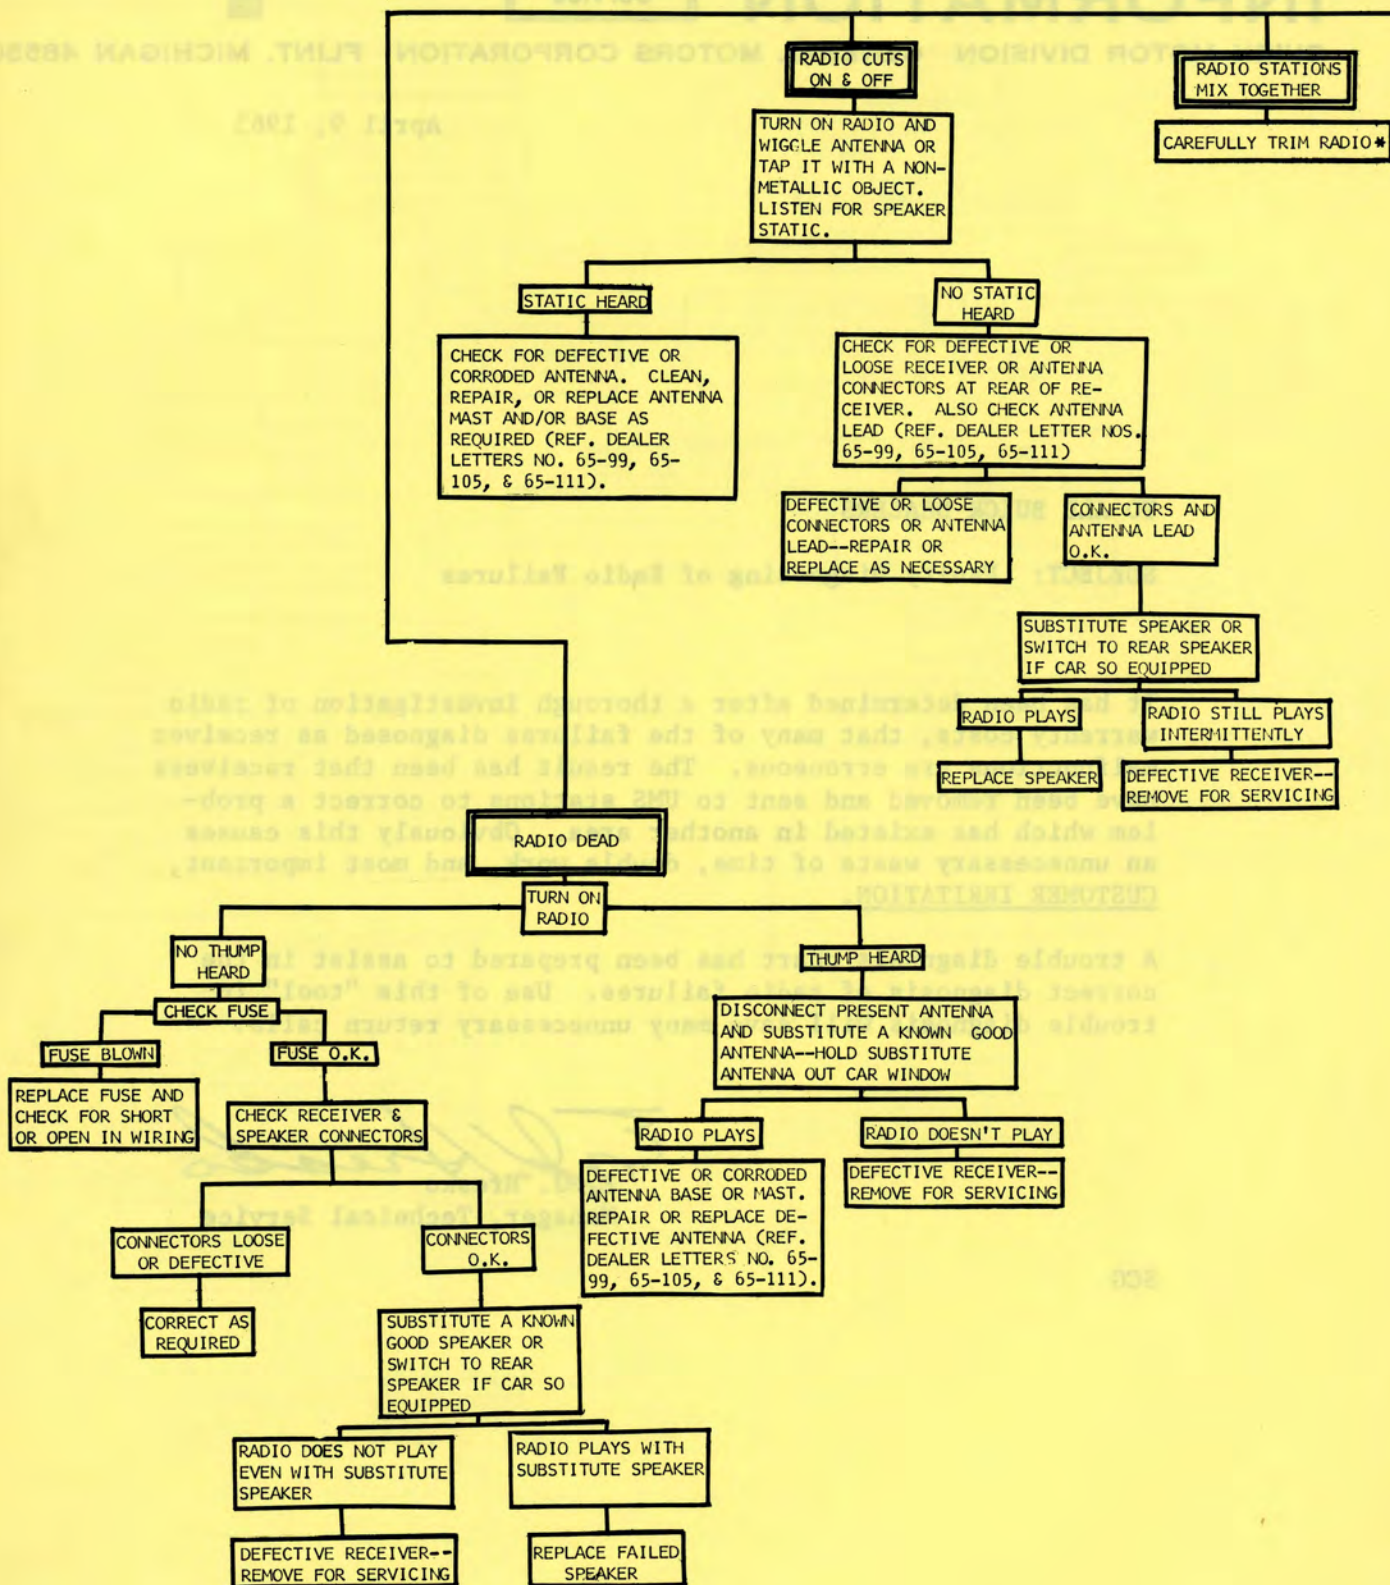
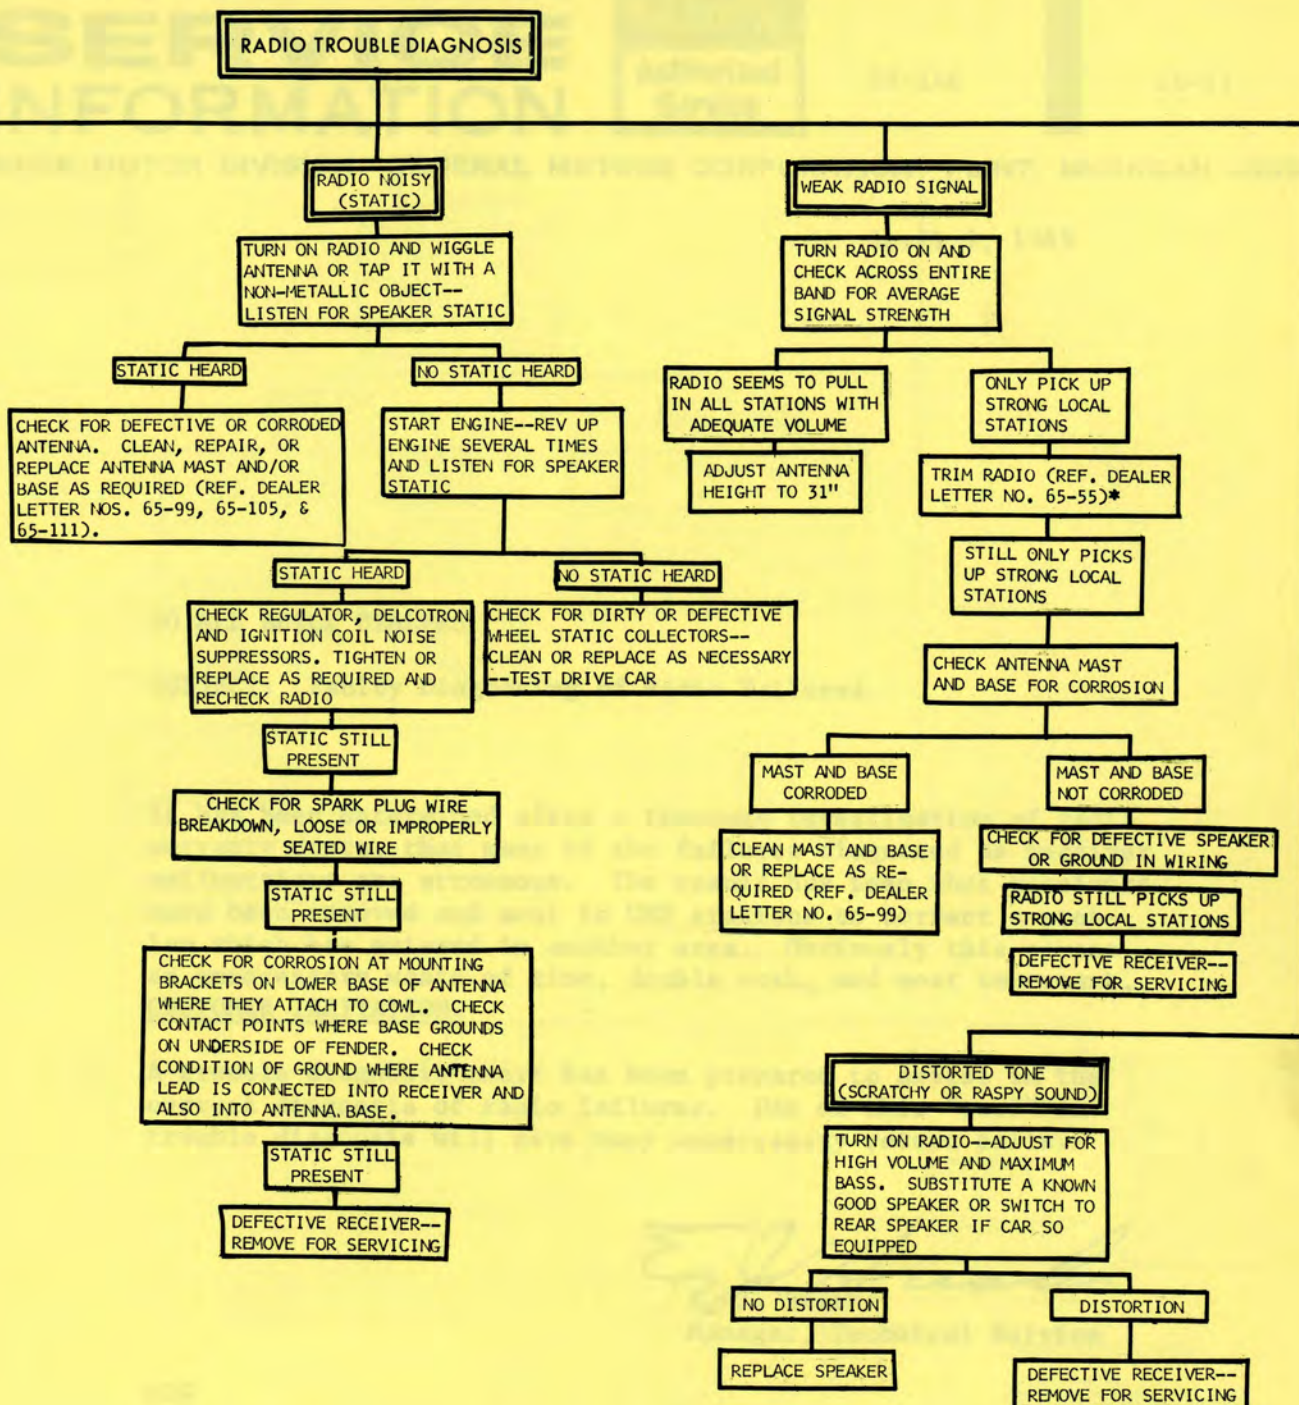
It has been determined after a thorough investigation of radio warranty costs, that many of the failures diagnosed as receiver malfunctions are erroneous. The result has been that receivers have been removed and sent to UMS stations to correct a problem which has existed in another area. Obviously this causes an unnecessary waste of time, double work, and most important, CUSTOMER IRRITATION.

A trouble diagnosis chart has been prepared to assist in the correct diagnosis of radio failures. Use of this "tool" in trouble diagnosis will save many unnecessary return calls.

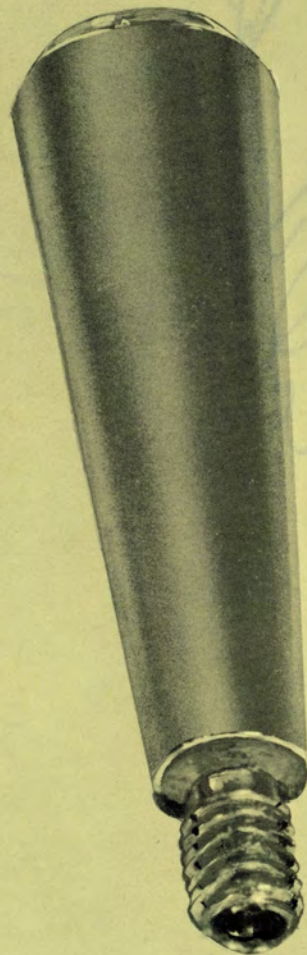
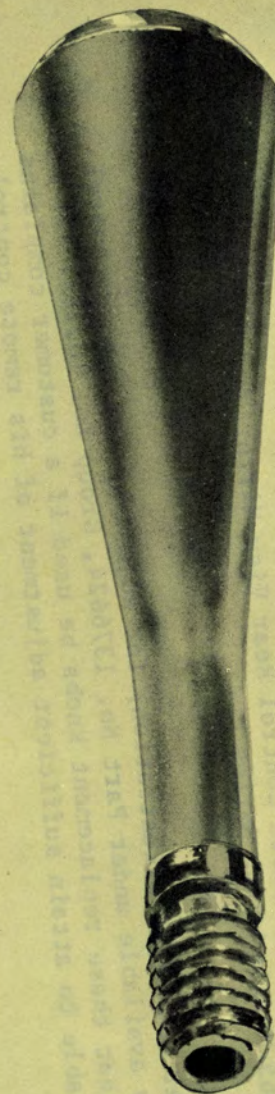
A new narrower knob (see illustration) for adjusting the remote control mirror is now available under Part No. 1376624, Group No. 10.185. It is recommended that these replacement knobs be used if a customer complains that he is unable to attain sufficient adjustment of his remote control mirror.

PRESENTLY USED KNOB

REPLACEMENT KNOB  
(PART NO. 1376624 -  
GROUP NO. 10.185)

To replace knob, unscrew and discard present knob. Screw in new part and tighten using pliers. It is suggested that prior to tightening knob with pliers, a cloth be wrapped around knob to protect finish.
